89-1, *Publication Date: JANUARY 11, 1989*

Air Conditioning - FS-6 Compressor Drive Belt Rolls Over Or Jumps Off Compressor Pulley - Vehicles With 6.6L And 7.8L Ford Diesel Engines	Article No. 89-1-17
--	--------------------------------

MEDIUM/HEAVY TRUCK:

1988 and prior F, B, L-SERIES, CARGO

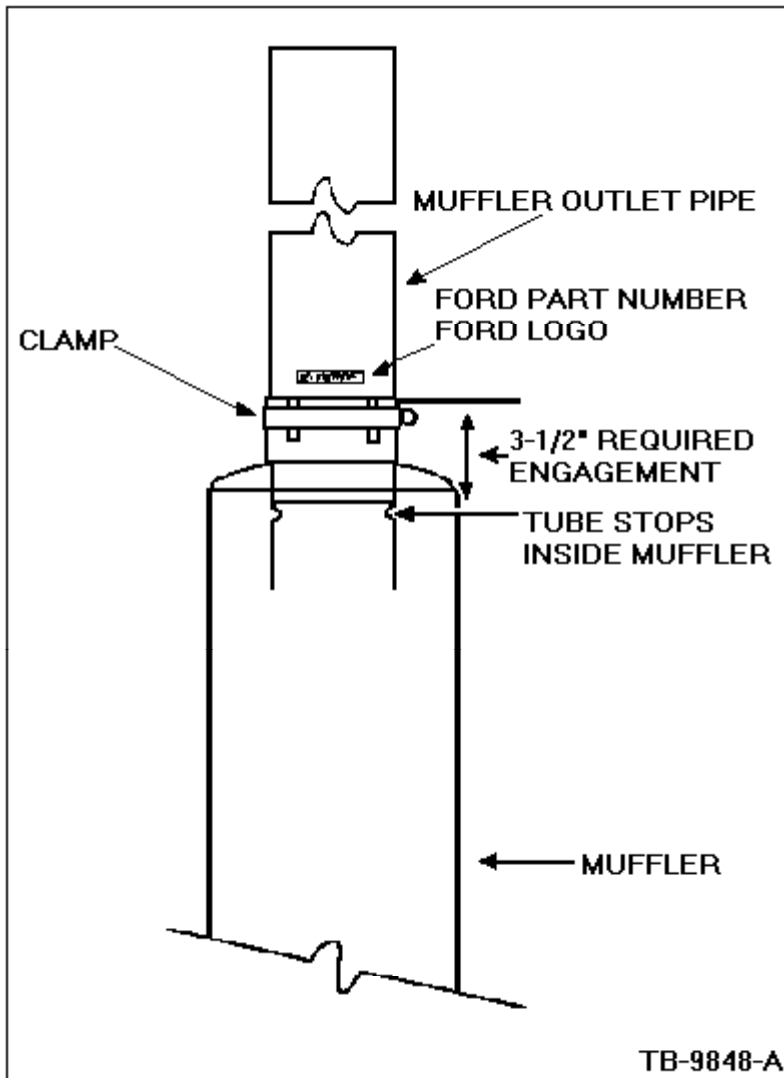
Figure 1 - Article 89-3-14

Exhaust system mufflers that crack above the outlet pipe welds may be caused by incorrect installation of the muffler outlet pipe. The muffler outlet pipe must be "bottomed out" against the stops inside the muffler.

1. Install the muffler outlet pipe. Make sure the Ford part number and Ford logo are positioned at the muffler outlet, Figure 1.

2. Insert the muffler outlet pipe into the muffler about 3 1/2", until it "bottoms out" against the stops inside the muffler.
3. Position the exhaust clamp about in the middle of the muffler outlet slots, Figure 1.
4. Tighten the clamp bolts to a torque of 10-12 lb.ft. (14-16 N-m).

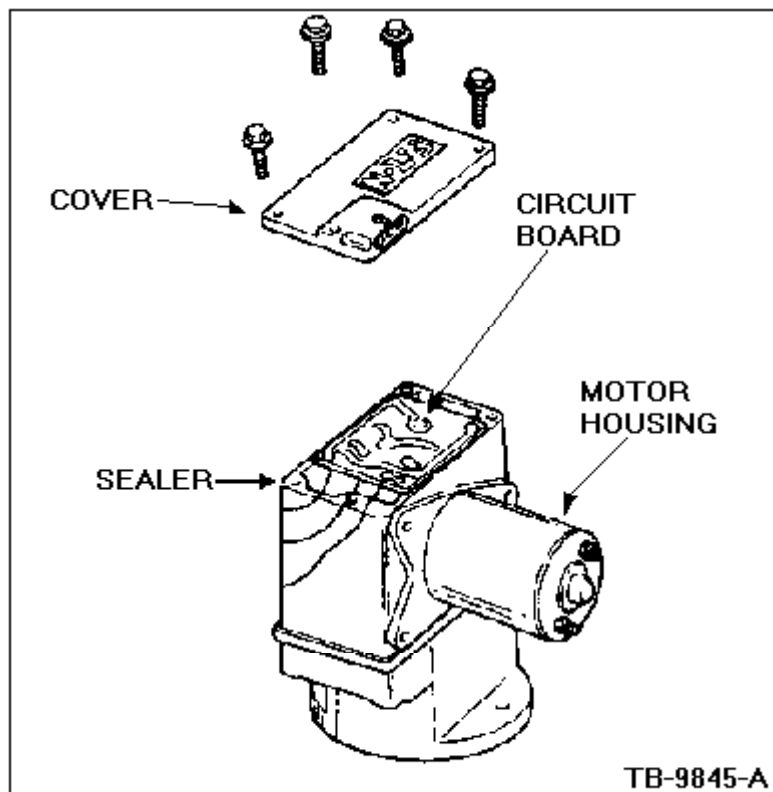
Figure 1 - Article 89-3-15

Improper re-sealing of the Eaton two speed electric shift motor cover could allow contaminants to enter the assembly and cause the internal circuit board to fail.

Anytime the Eaton two speed electric shift motor cover is removed, install a new cover gasket and apply Ford non-acid silicone rubber sealant, Figure 1.

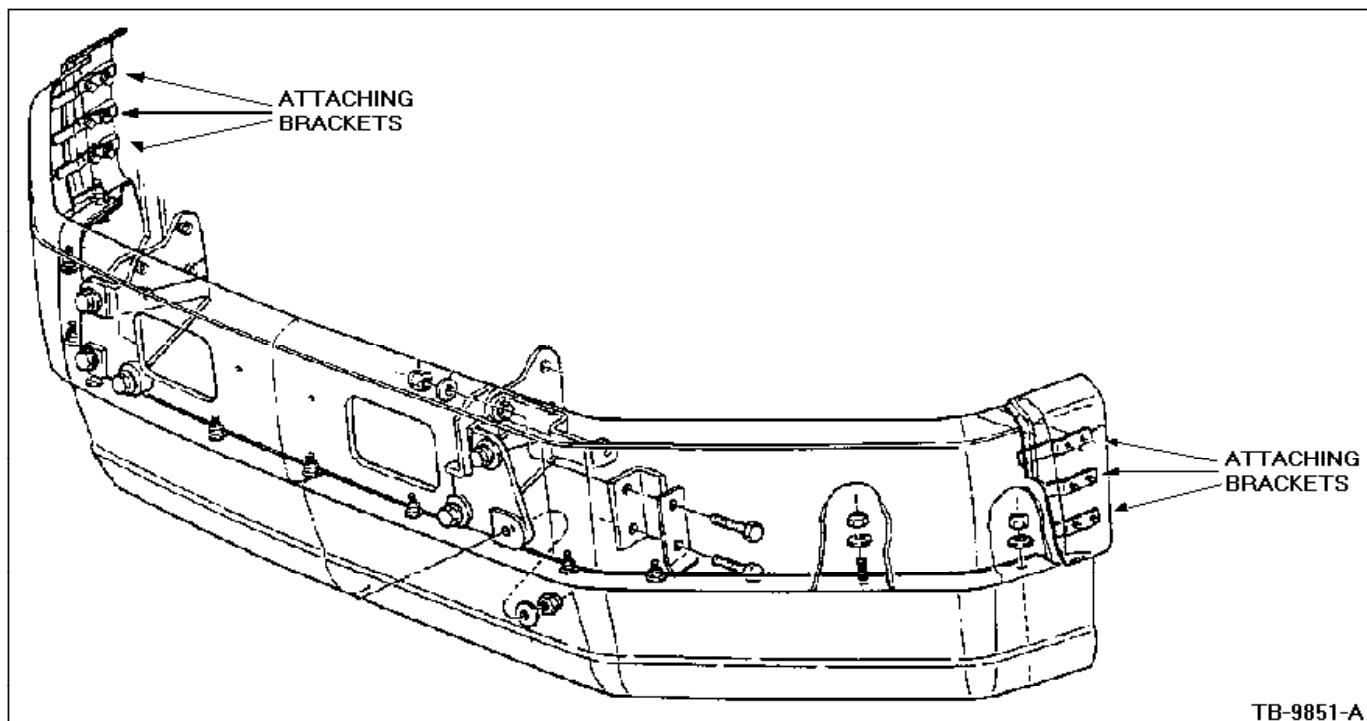
Figure 1 - Article 89-4-12

Loose and vibrating air foil ends on the front bumper of the Aero Max truck may be caused by the six (6) bracket attachment method used to hold the air foil to the front bumper.

1. Remove the three (3) brackets from the end of the air foil, Figure 1.

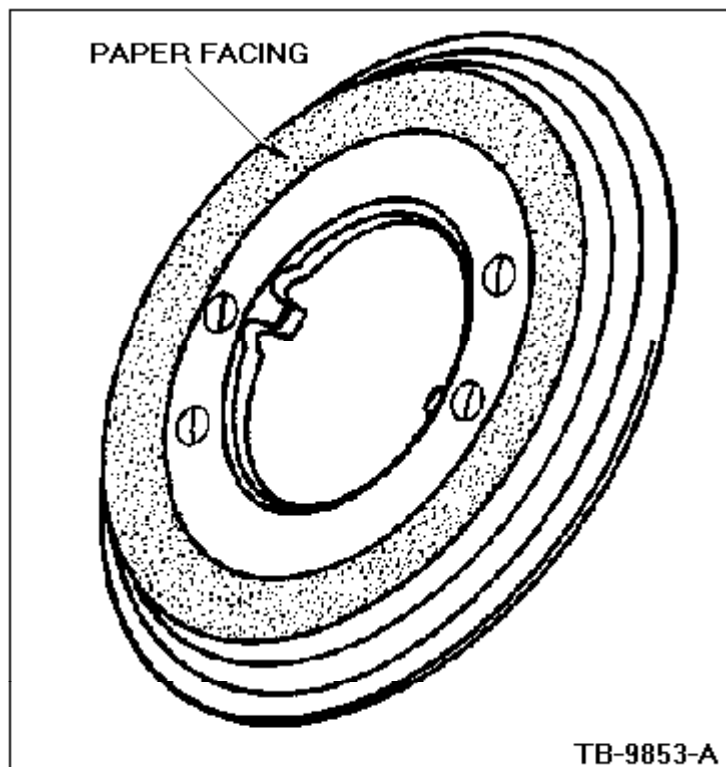
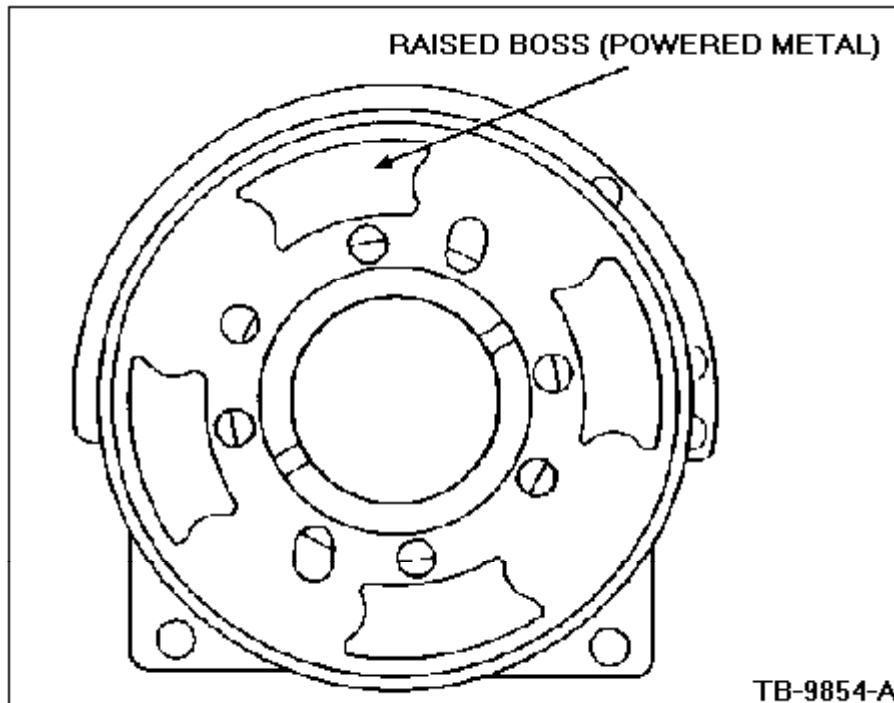
A damaged input bearing cover or release bearing backing plate may be caused by the clutch brake. The clutch brake has a powdered metal facing that may cause the transmission input bearing cover or the release bearing backplate to wear excessively.

THE NEW CLUTCH BRAKE CAN BE IDENTIFIED BY REFERRING TO FIGURE 1. THE OLD CLUTCH BRAKE CAN BE IDENTIFIED BY REFERRING TO FIGURE 2.

Inspect and adjust the clutch brake to determine if replacement is required. The new clutch brake has a paper facing to reduce input bearing cover and release bearing backing plate wear.

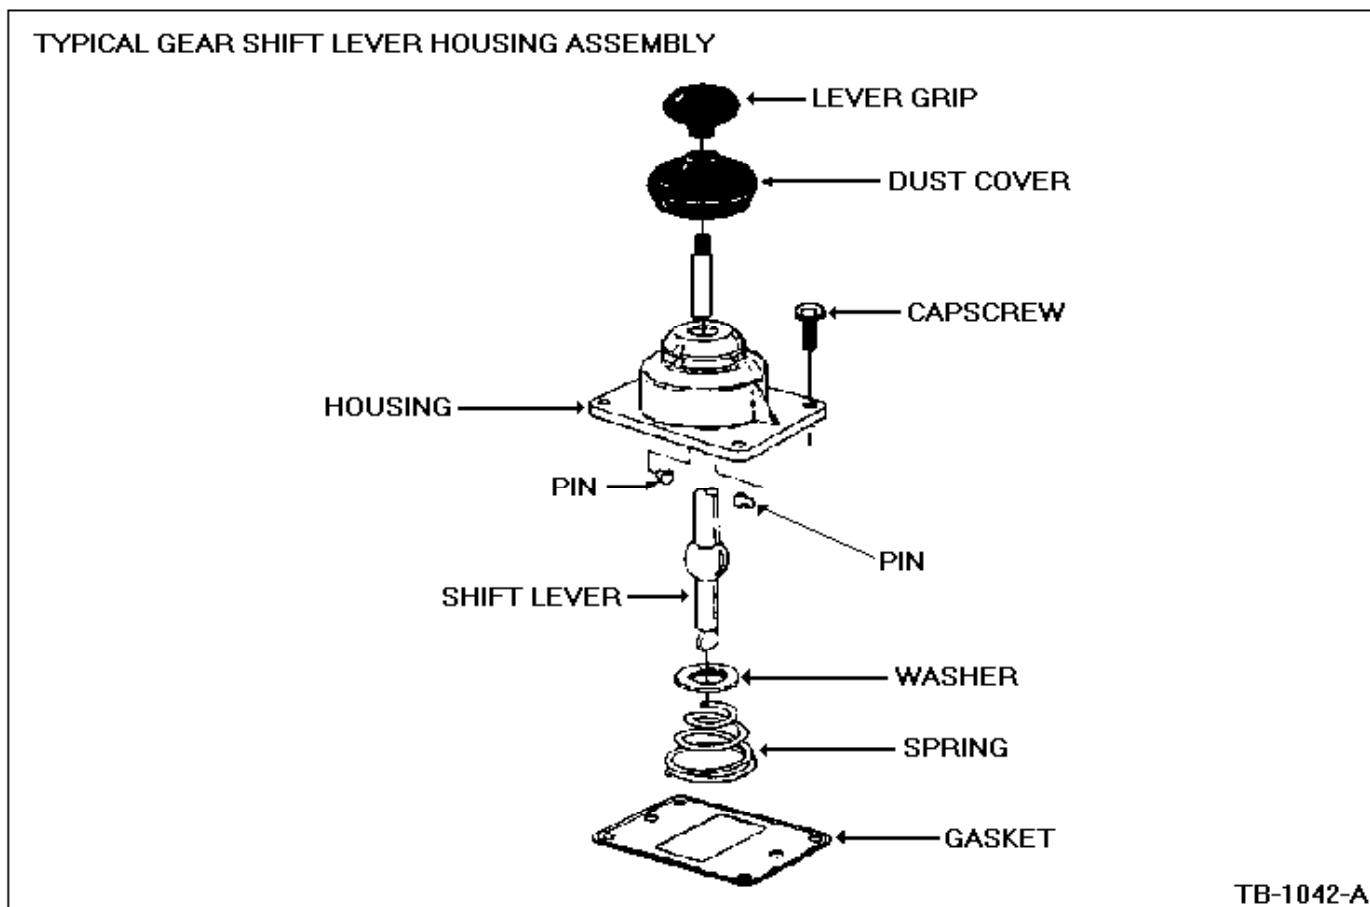
Figure 1 - Article 89-5-18

A "rattling" or "buzzing" noise in the passenger cab may be caused by a shift lever that vibrates.

1. Remove the gear shift lever, Figure 1. Refer to the L-Series Shop Manual, Section 16-57 for removal instructions.

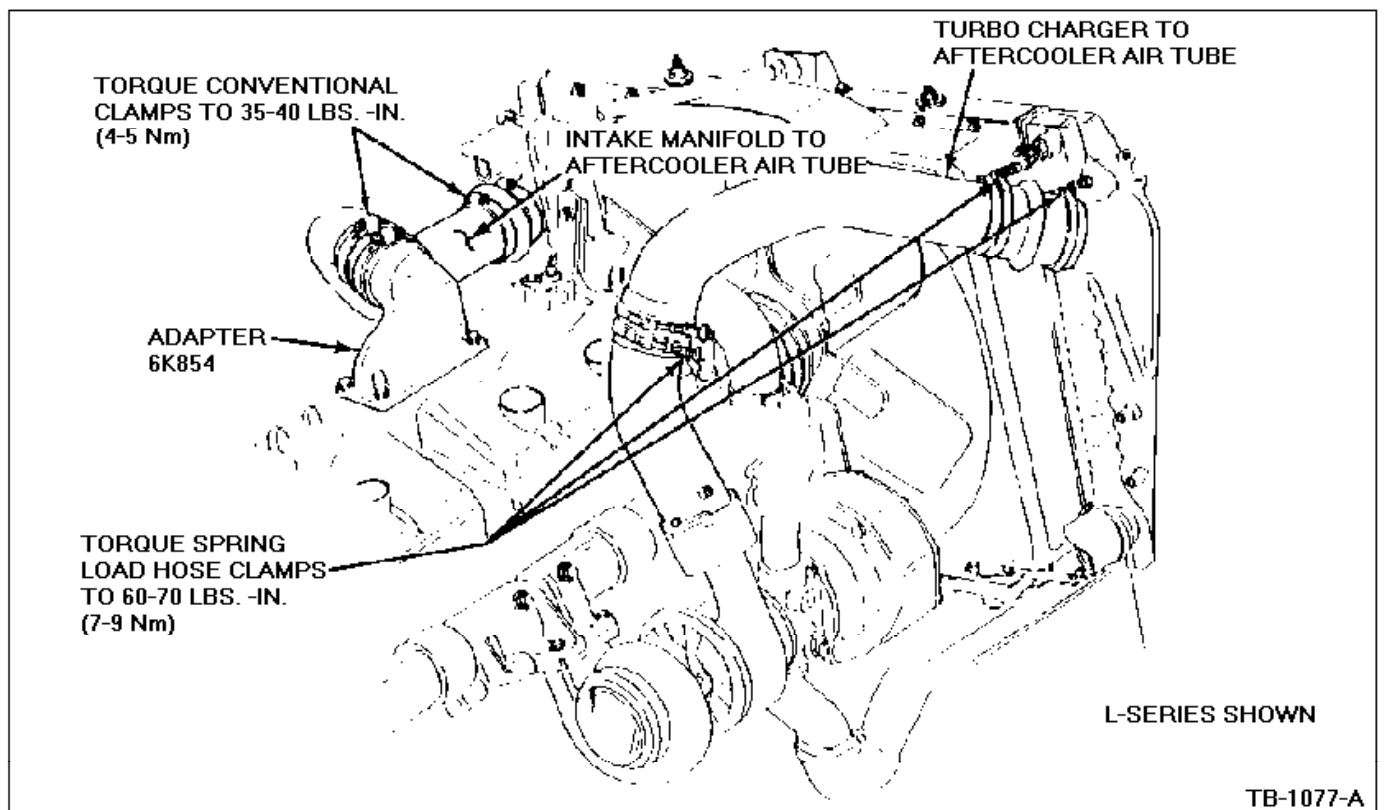
Figure 1 - Article 89-9-19

Turbocharger air hoses connecting the air tubes of the air-to-air aftercooler to the engine may disconnect from the aluminum tubes. Overtightening of the hose clamps can cause the air tubes to collapse and come loose.

1. Remove the existing turbocharger to aftercooler air tube, Figure 1.

2. Remove the existing intake manifold to aftercooler air tube, Figure 1.
3. Remove the existing intake manifold air tube adapter.
4. Clean the gasket surface on the intake manifold.
5. Install a new adapter gasket and air tube adapter on the intake manifold.
6. Install a new turbocharger to aftercooler air tube as shown in Figure 2.

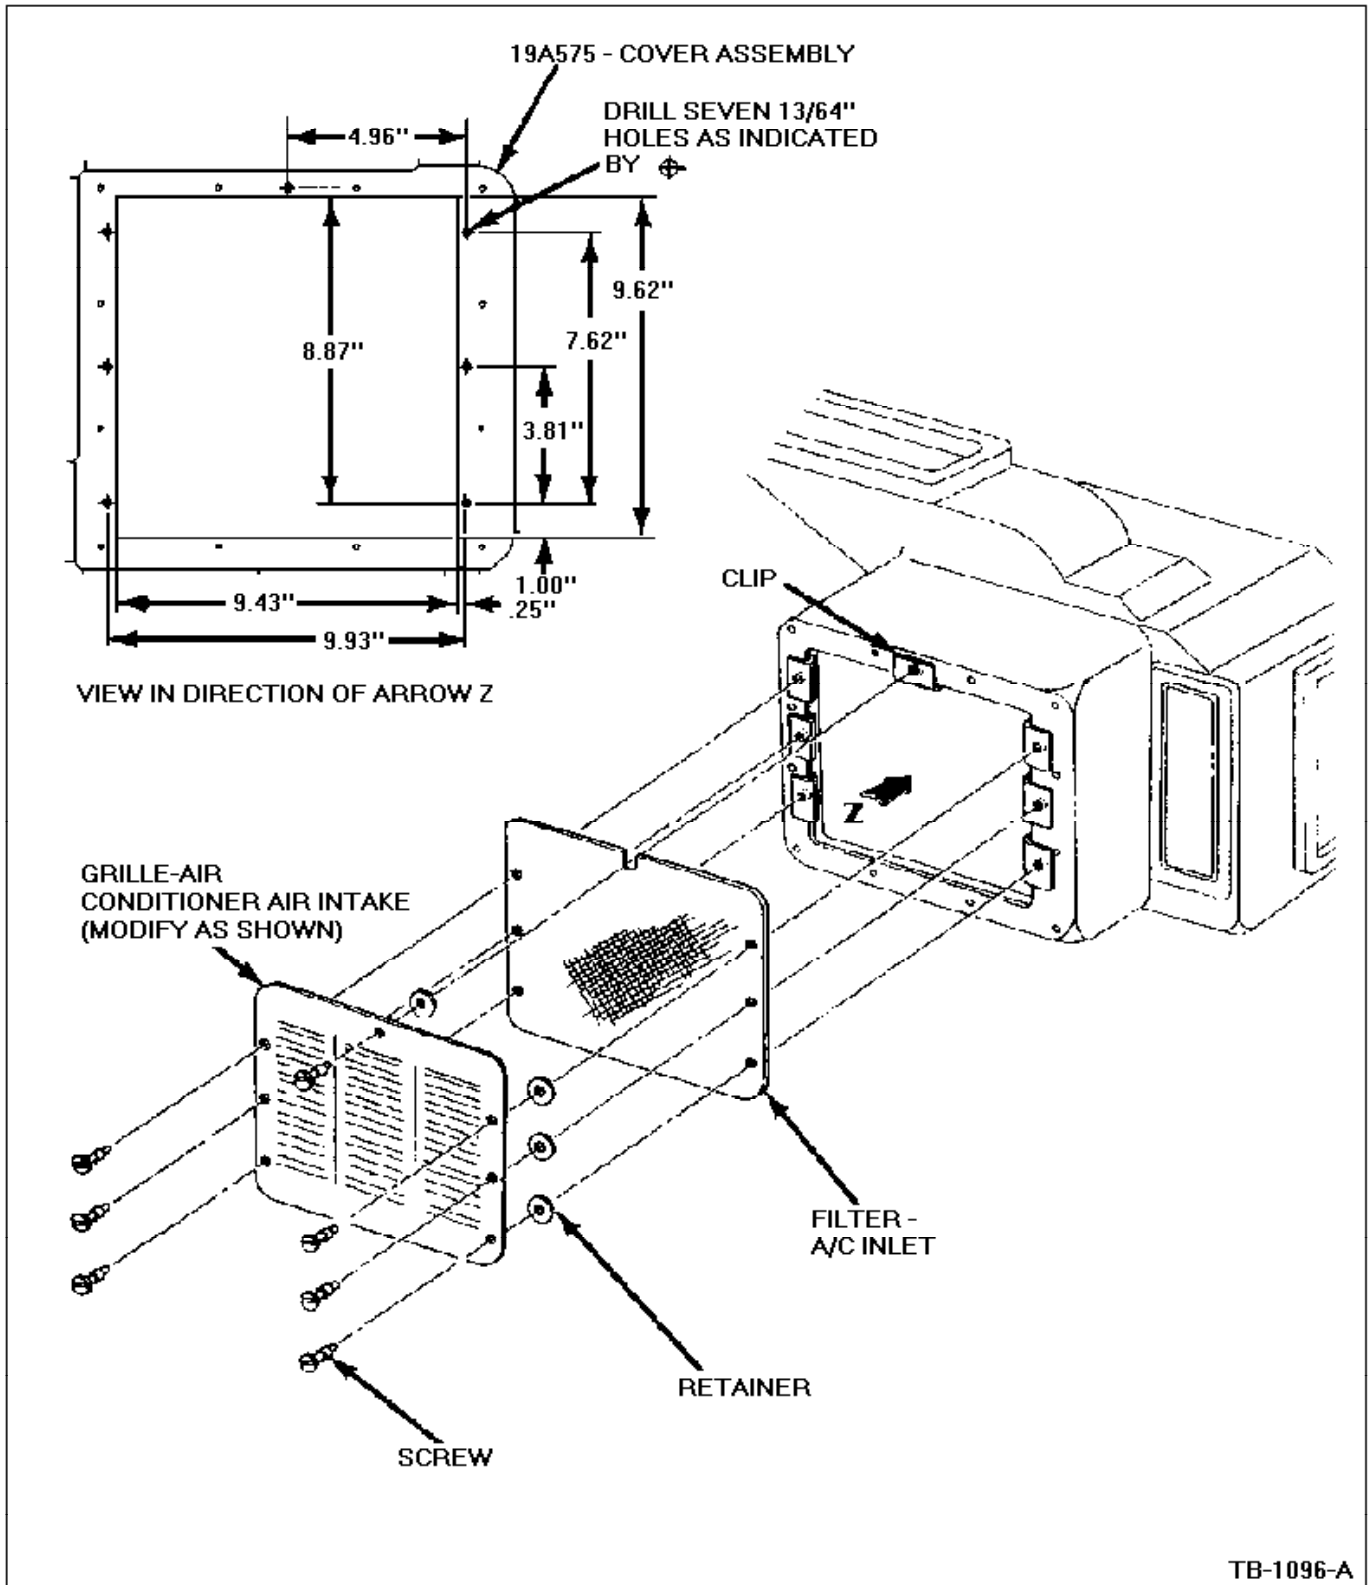
Figure 1 - Article 89-11-12

Condensation (water) leaking on the floor of the cab on the passenger's side of the truck may be caused by lint accumulating and clogging the evaporator case condensation drain. A new evaporator case filter is now available to prevent lint from entering the A/C housing and clogging the condensate drain. The new evaporator case filter is serviced from inside the cab and it can be removed to wash off trapped lint.

Install an air conditioning evaporator case filter to prevent lint from clogging the A/C condensate drain. Refer to the following procedure for service details.

1. Remove the existing grille from the A/C evaporator case housing. Be careful not to break off the corners when prying up the plastic studs.
2. Remove the existing clips that hold the grille to the evaporator case housing.
3. Position the grille on the evaporator case housing by inserting the grille studs into the housing locator holes.
4. Drill seven (7) 13/64" holes through the grille and evaporator case housing in the locations shown in Figure 1, View "Z".

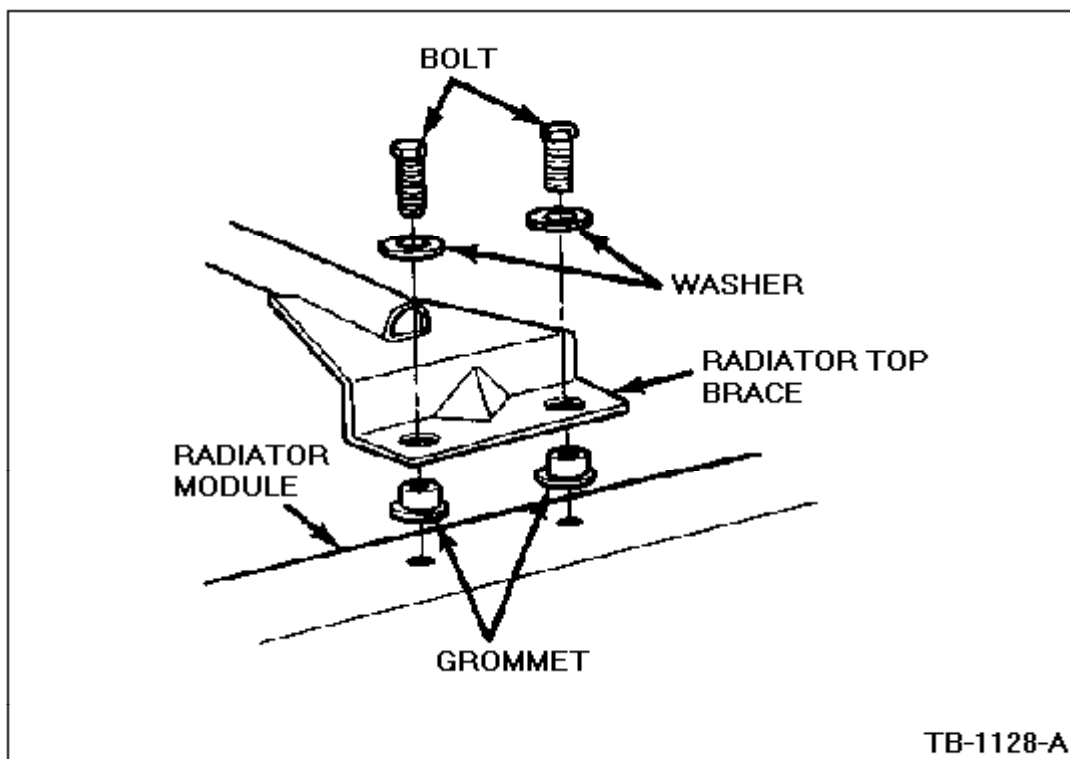
Figure 1 - Article 89-11-13

A loose radiator support bar or radiator brace may be caused by loose, missing or cross-threaded attaching bolts. This condition could allow the radiator to shift rearward and contact the engine cooling fan.

1. Inspect the bolts that hold the radiator brace to the radiator, Figure 1.

2. Determine if the bolts are loose, missing or cross-threaded in the upper aluminum extrusion of the radiator.
 - a. If the bolts are missing, check the radiator and fan for damage.
 - b. If the radiator or fan is damaged, replace as necessary. Refer to L-Series Heavy Truck Shop

- c. If bolts are loose or cross-threaded, check to make sure they are okay. If the bolts are damaged, throw them away.
 - d. Clean the threads of reusable bolts with a wire brush or threadchaser (die).
 - e. Make sure the bolts are 1.25" long.
3. Clean and repair the threads in the aluminum extrusion with a threadchaser (tap). If the threads are badly damaged, or if more than two threads are stripped out, use a helicoil to repair the threads.

4. Inspect the grommets, Figure 1.
 - a. Replace the grommets if they are damaged, cracked or worn.
 - b. Apply rubber lubricant on the grommets before inserting them into the radiator brace.
 - c. Make sure the grommets are fully seated.
5. Apply Ford Threadlocker on the bolts.
6. Install the bolts and tighten them to a torque of 20 lb.ft. (27 N-m).
