90-1, *Publication Date: JANUARY 4, 1990*

Hard Start - All With Duraspark II Ignition Modules - Revised Applications

**Article No.
90-1-5**

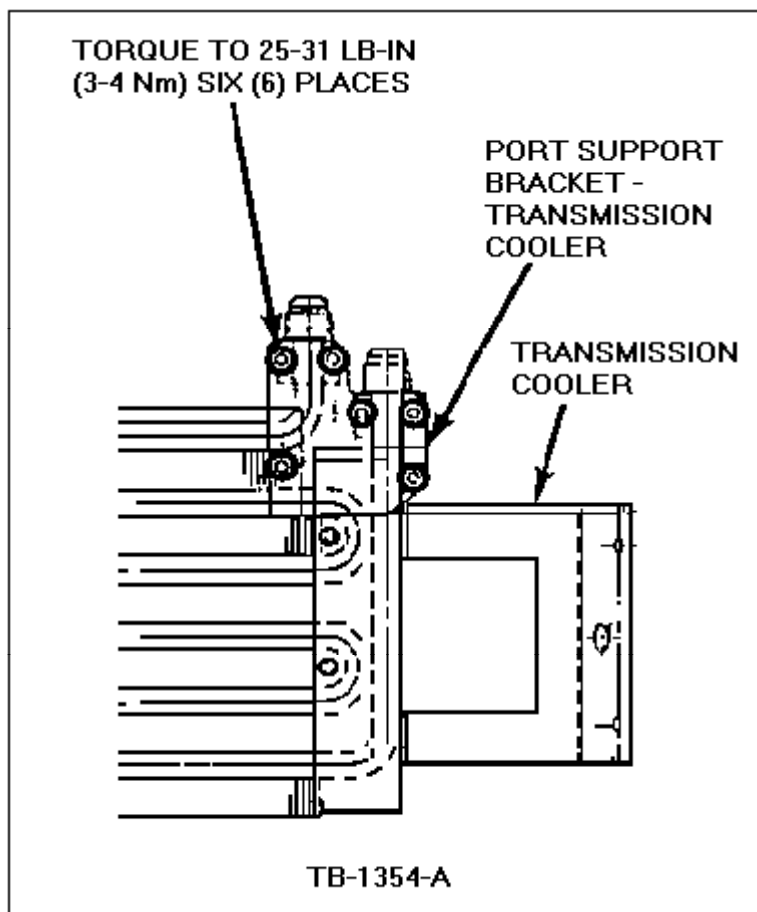
Figure 1 - Article 90-2-15

Damaged oil cooler inlet and outlet ports or leaking transmission fluid from the oil cooler tubes may be caused by the cooler tubes vibrating. The oil cooler tubes can vibrate if the cooler support bracket fasteners are loose or if a retaining clip lacks sufficient clamping force.

1. Tighten the oil cooler support bracket fasteners to a torque of 25-31 lb-in (3-4 N-m), Figure 1.

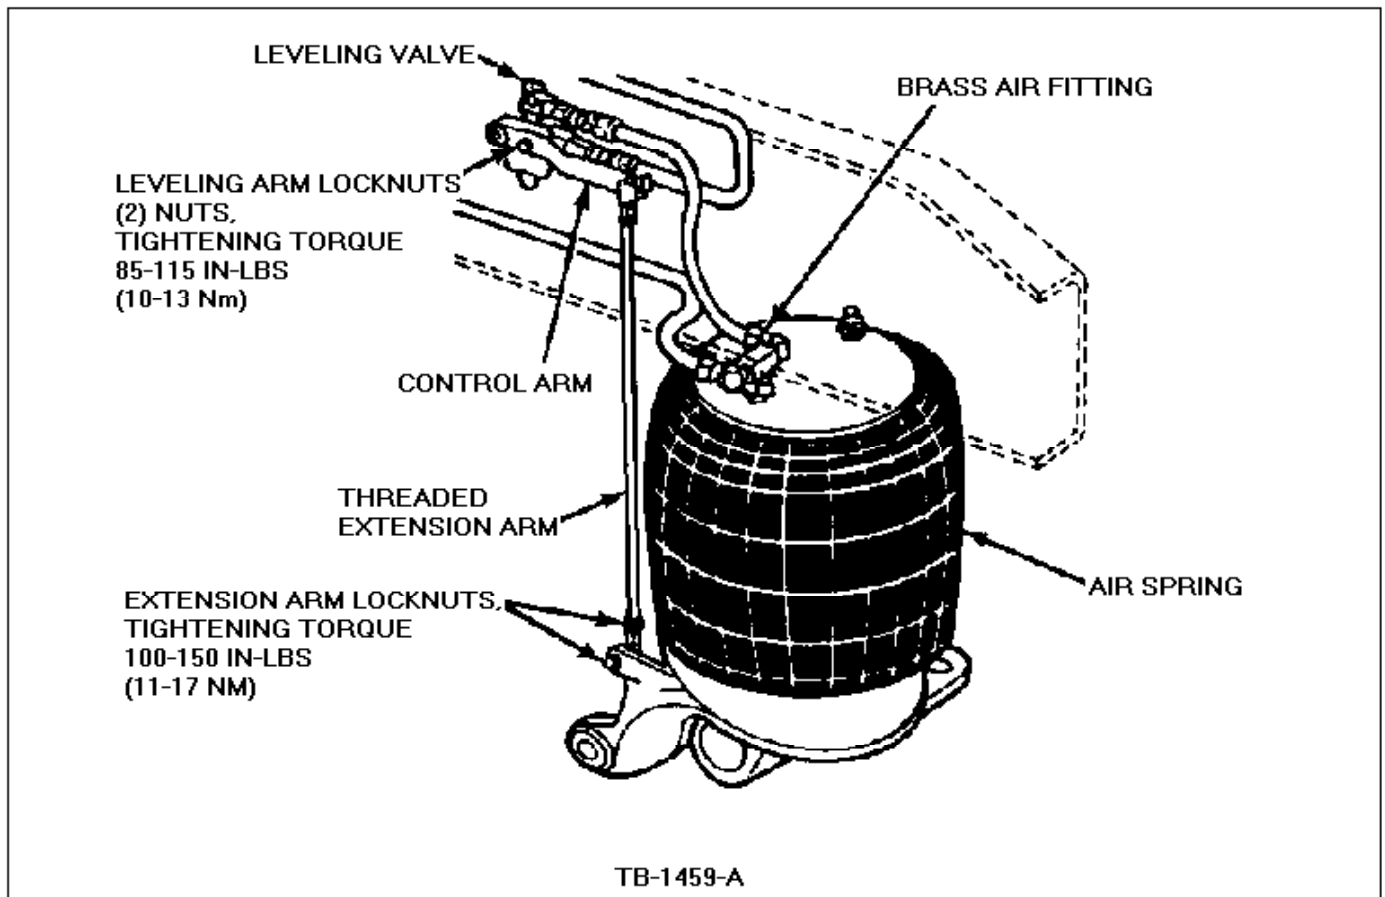
Figure 1 - Article 90-5-11

Rough ride or poor ride quality may be caused by the air suspension leveling valve. Units built before 11/30/89 used a leveling valve and mounting bracket with 1/4" mounting bolts that went through 3/8" mounting holes in the frame. This allowed the bolts to move in the frame holes and cause leveling valve misalignment. A leveling valve not adjusted to the proper ride height or the interface between the main support member and the frame hanger bracket not lubricated can also cause rough ride or poor ride quality.

1. Check to see that the main body of the leveling valve is vertical and the horizontal control arm is parallel to the frame flange, Figure 1.

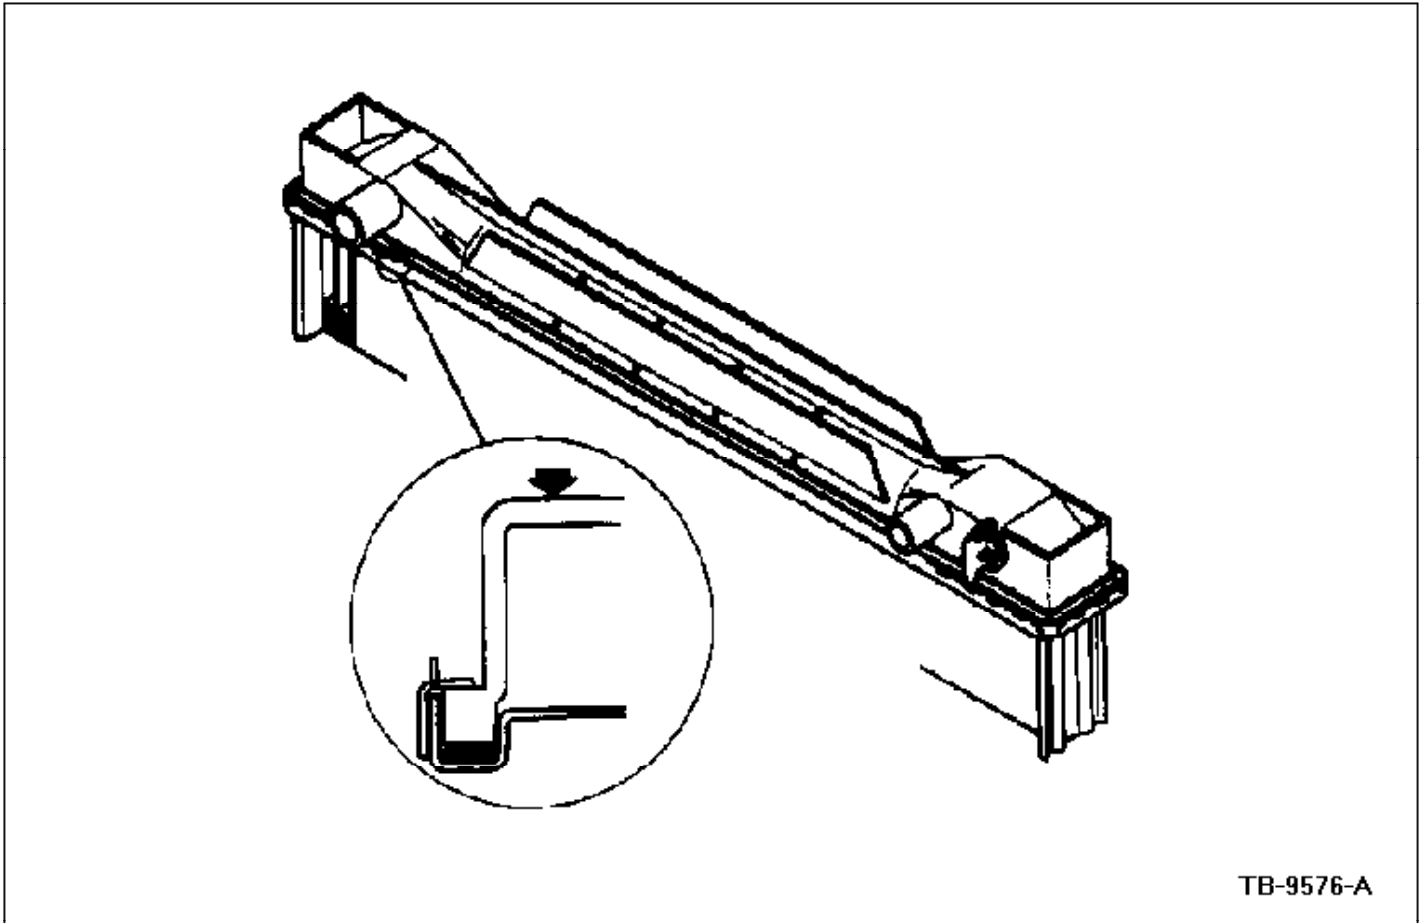
The radiator tanks are molded glass-filled nylon and are secured to the core header by locking strips, Figure 6. If damaged, replace the tank. Do not attempt to repair or reseal it.

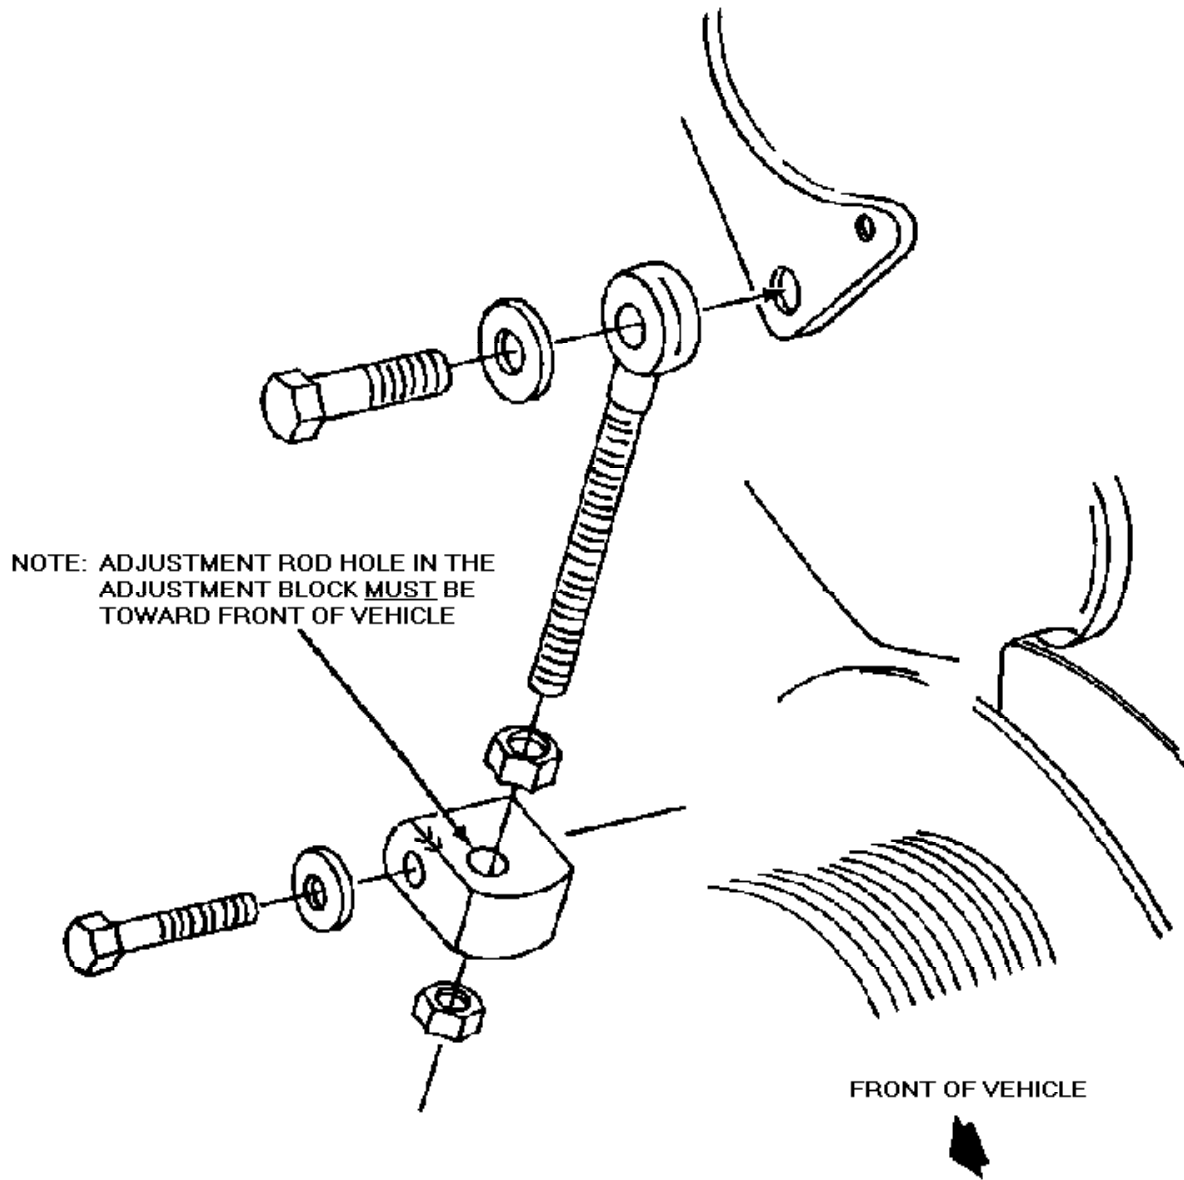
FNH A/C COMPRESSOR ADJUSTMENT BLOCK

An air conditioner compressor drive belt that rolls off the compressor pulley may be caused by misaligned crankshaft and idler pulleys. This may be caused by an incorrectly installed adjustment block on the adjustment rod of the compressor mount.

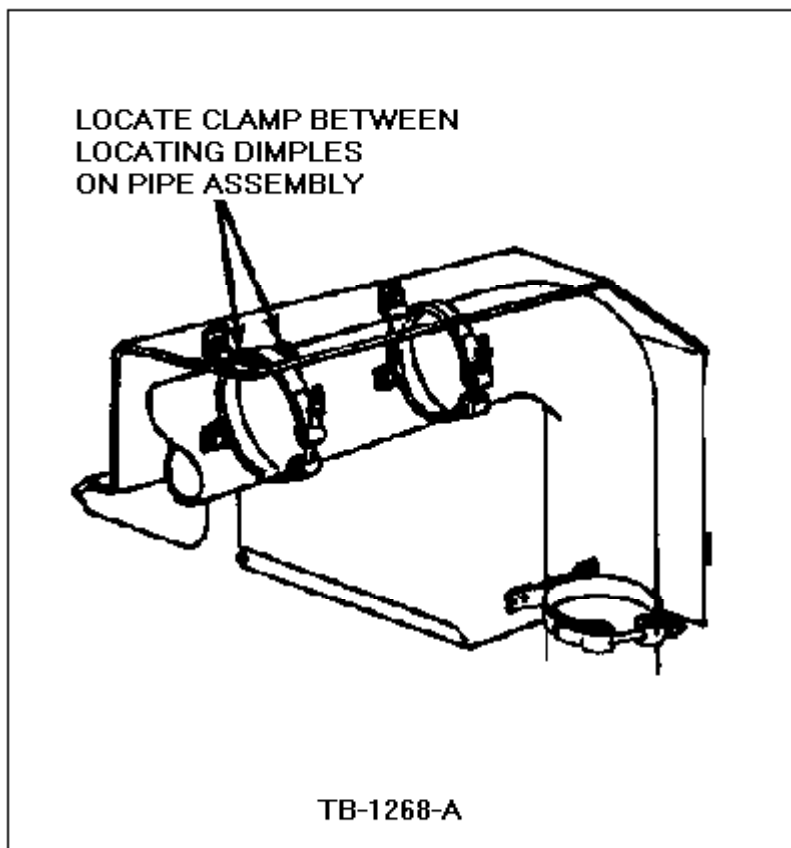
Figure 1 - Article 90-6-17

The clamp attaching the exhaust heat shield to the muffler inlet pipe may crack or break at the spot welds because of the weakness of its stainless steel weld joints.

Install new clamps made of zinc coated, low carbon steel which are more durable and a new heat shield, Figure 1. Tighten clamps to 85-115 lb-in (10-13 N-m).

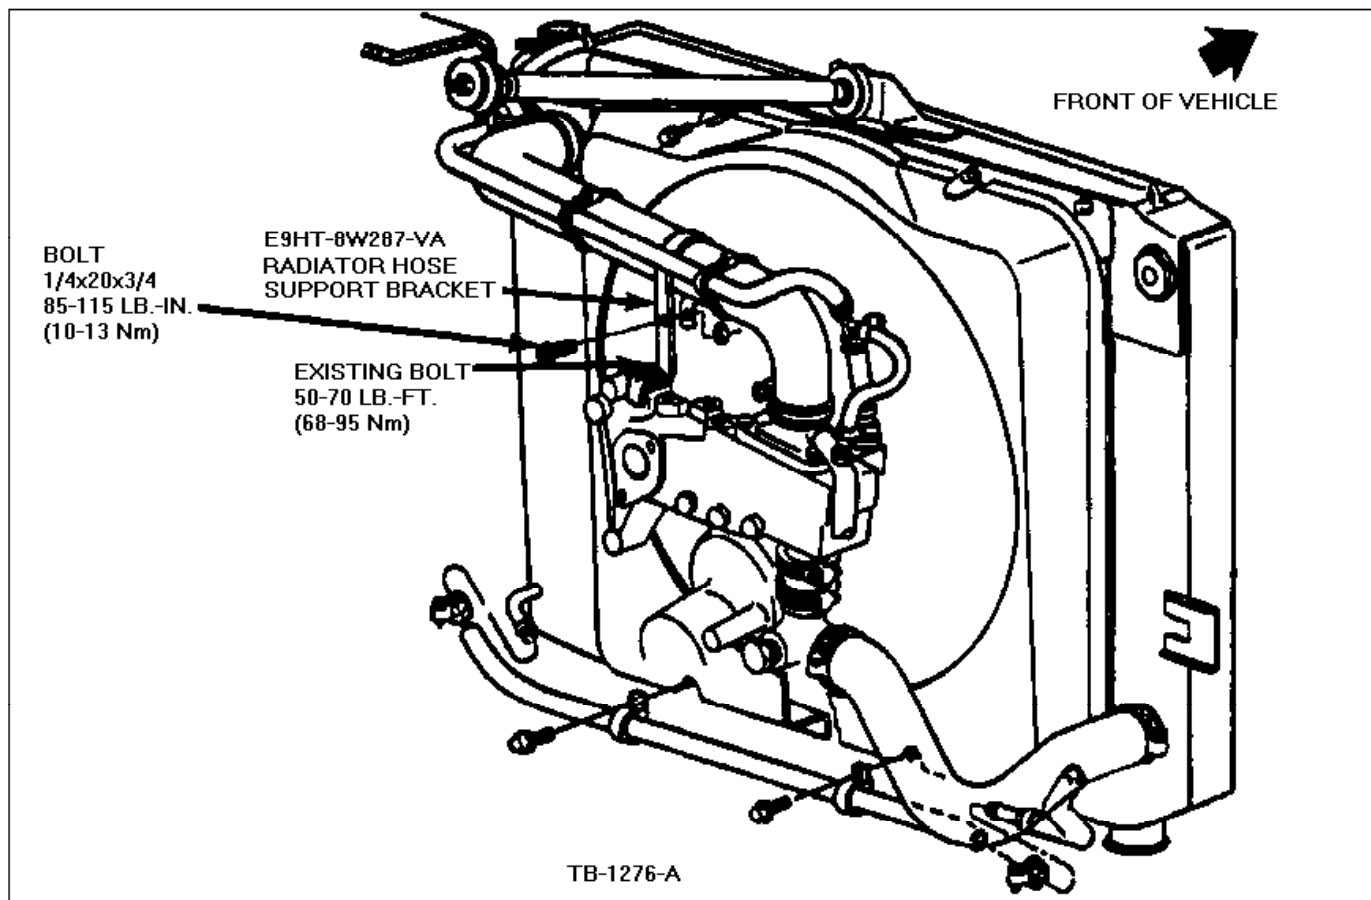
Figure 1 - Article 90-9-10

Radiator - 6.6L And 7.8L Diesel Engine - Upper Hose Ruptures At Support Bracket

1. Remove the old upper radiator support bracket, Figure 1. Save the existing bolt for securing the new bracket.

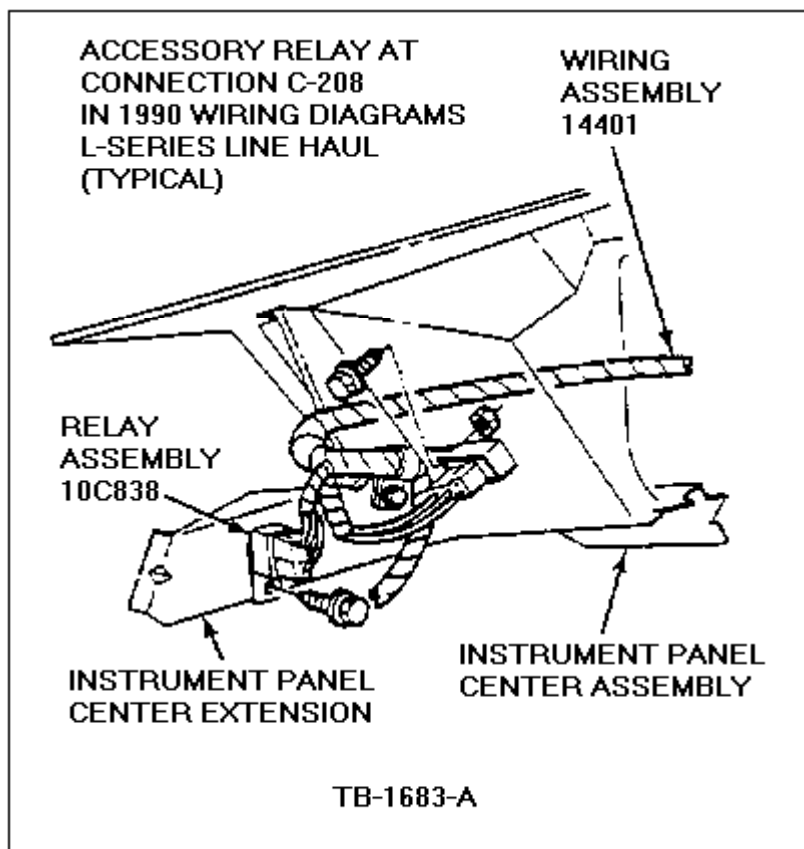
Figure 1 - Article 90-12-14

1. Use the vehicle wiring diagrams to determine the location of the various ground connections that pertain to the effected circuits. For example, a loose ground wire such as that shown in Figure 1, can cause the heater blower to seek ground through the engine temperature gauge.

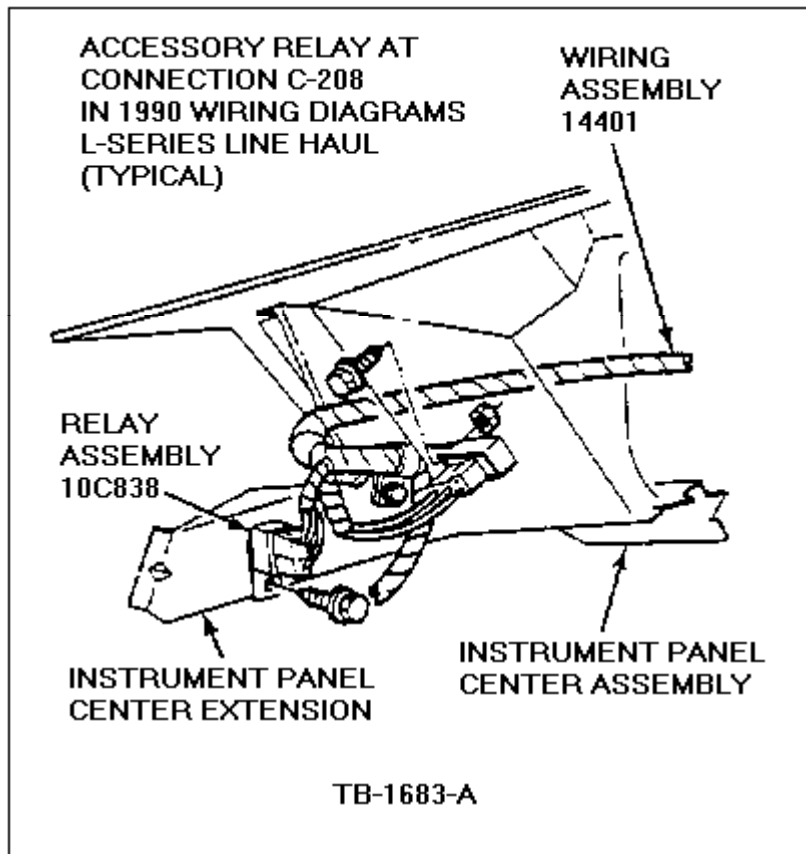
Figure 2 - Article 90-12-14

2. Look for self-grounding relays that may have loose mounting screws. This condition, shown in Figure 2, can cause flickering lights and an erratic performing/inoperative radio or blower.
