91-2, *Publication Date: JANUARY 23, 1991*

MEDIUM/HEAVY TRUCK:

1987-91 CARGO SERIES, F & B SERIES, L SERIES

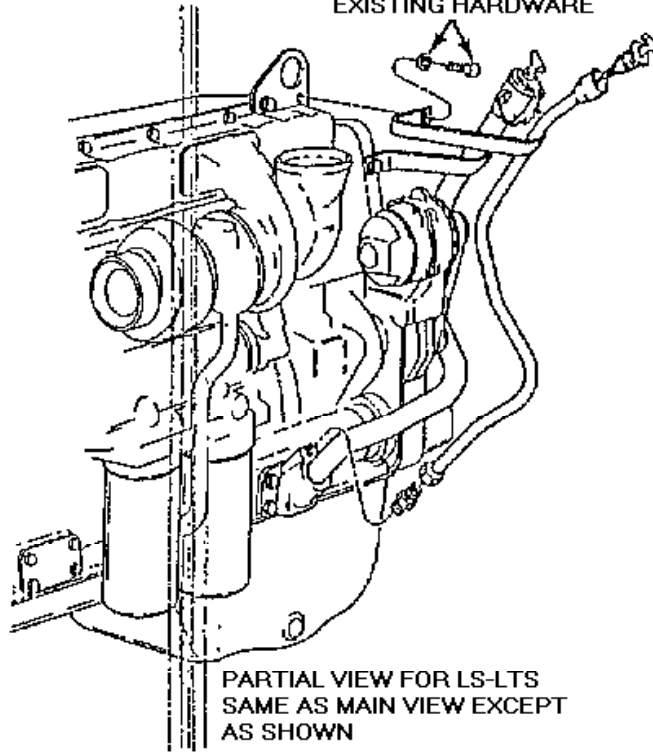
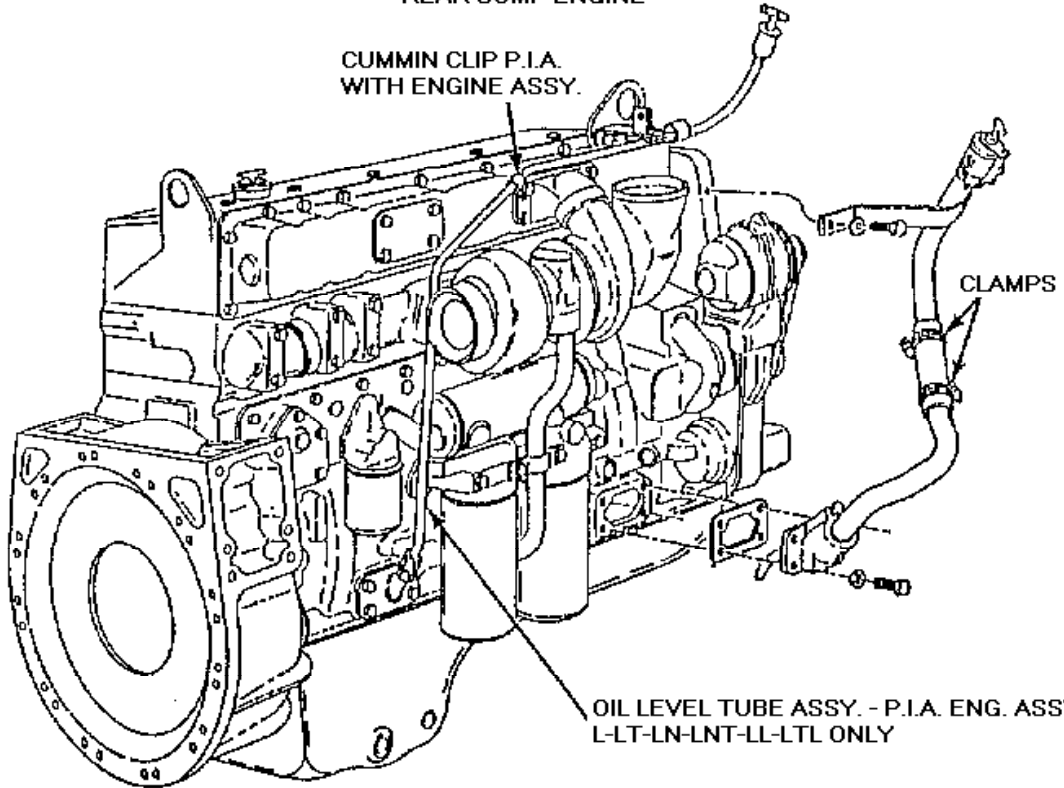
Figure 1 - Article 91-3-13

The one-piece oil filler tube assembly may crack where the tube is welded/brazed to the mounting plate. In addition, the dipstick guide tube may interfere with the oil pick-up tube on rear sump oil pan applications. An oil leak may result because this interference causes the mounting plate not to rest flat against the engine mounting surface.

Use the following procedure to eliminate the interference condition on rear sump engines.

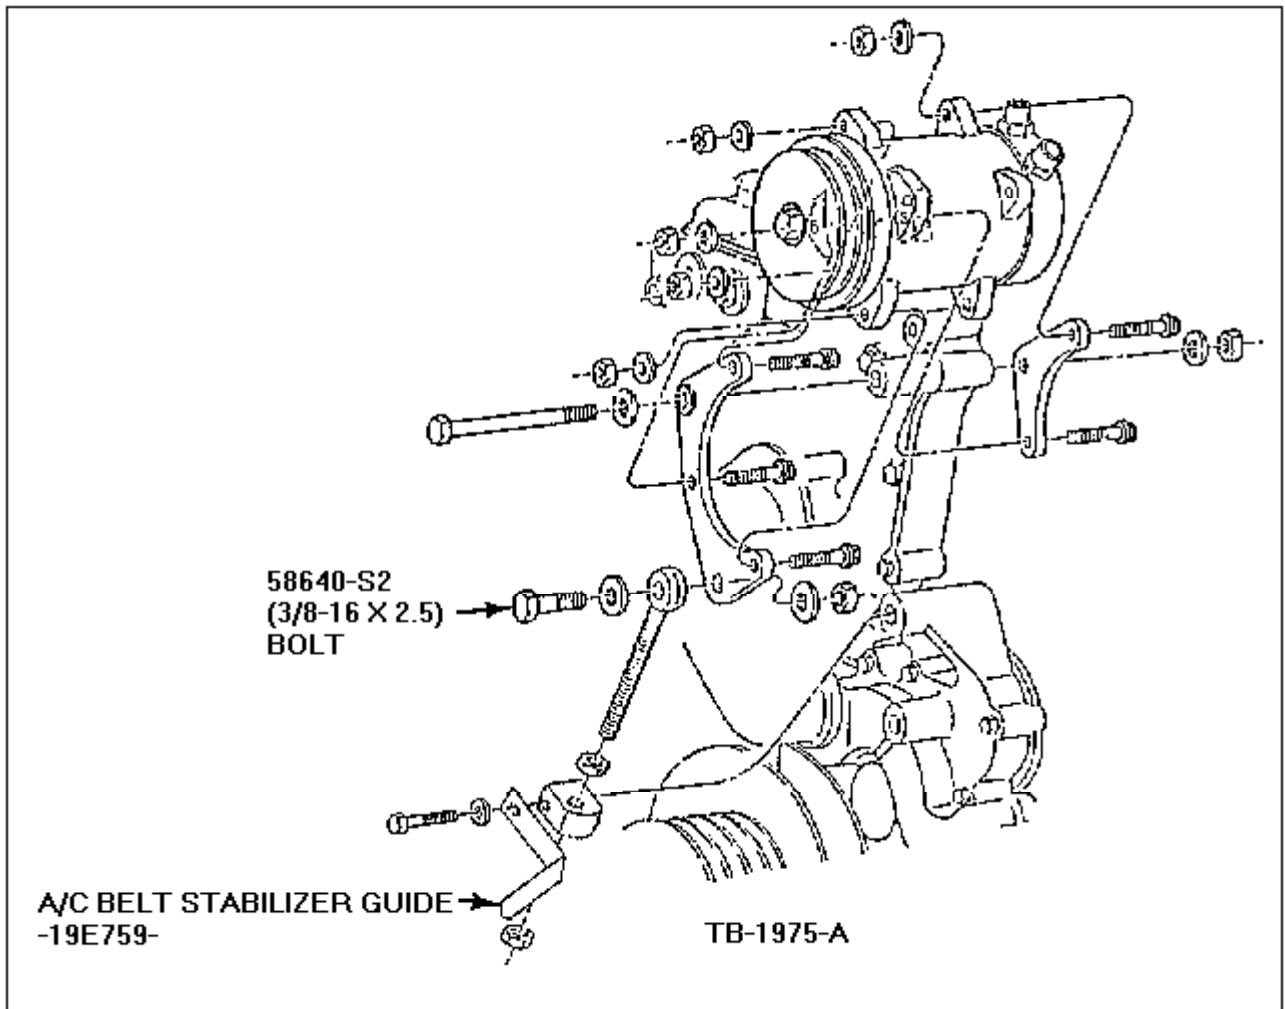
Figure 1 - Article 91-5-13

Air conditioning drive belts may jump off during normal operation on some trucks. This occurs because of differences in belt alignment/tensioning and design tolerance variations.

1. Use a 1/2" drive belt for both the 6.6L and 7.8L engine applications.
 - 6.6L - Use belt C9PZ-8620-CZ
 - 7.8L - Use belt E4PZ-8620-B
2. Install a drive belt stabilizer guide (F1HZ-19E759-A) on the tension side of the the belt circuit, Figure 1.

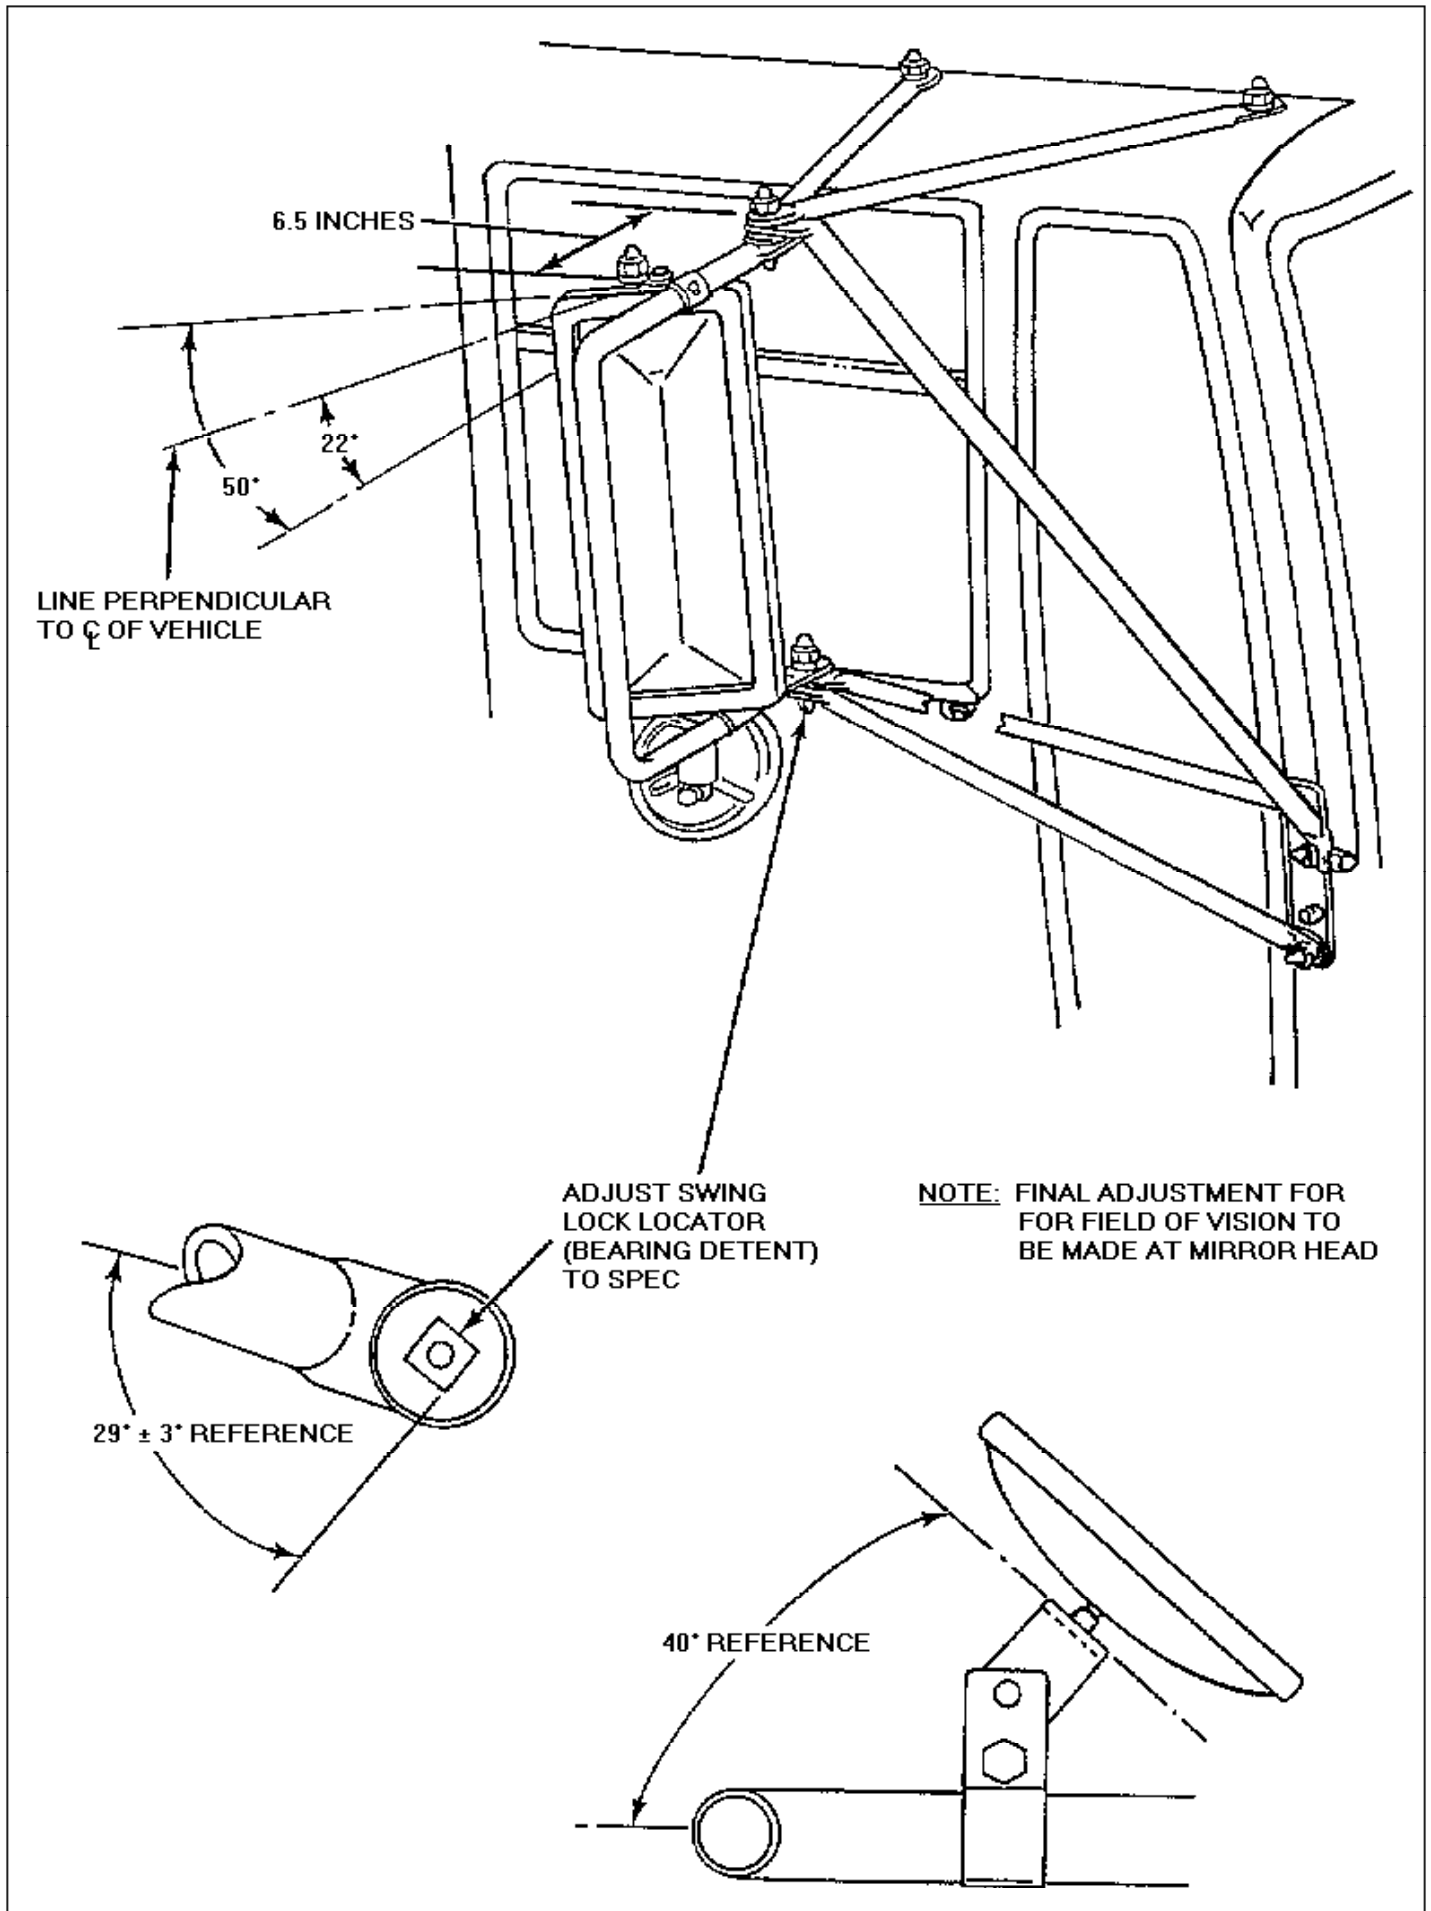
Figure 1 - Article 91-6-8

Some trucks may have been shipped with the RH rear view mirror improperly adjusted. The mirror may be in such a position that a portion of it is obstructed from the driver's view by the vertical bar separating the windows in the door.

Adjust the RH rear view mirror to provide adequate visibility, Figure 1. Refer to the 1991 Cargo Truck Shop Manual, Section 35-50, for correct installation torque specifications.

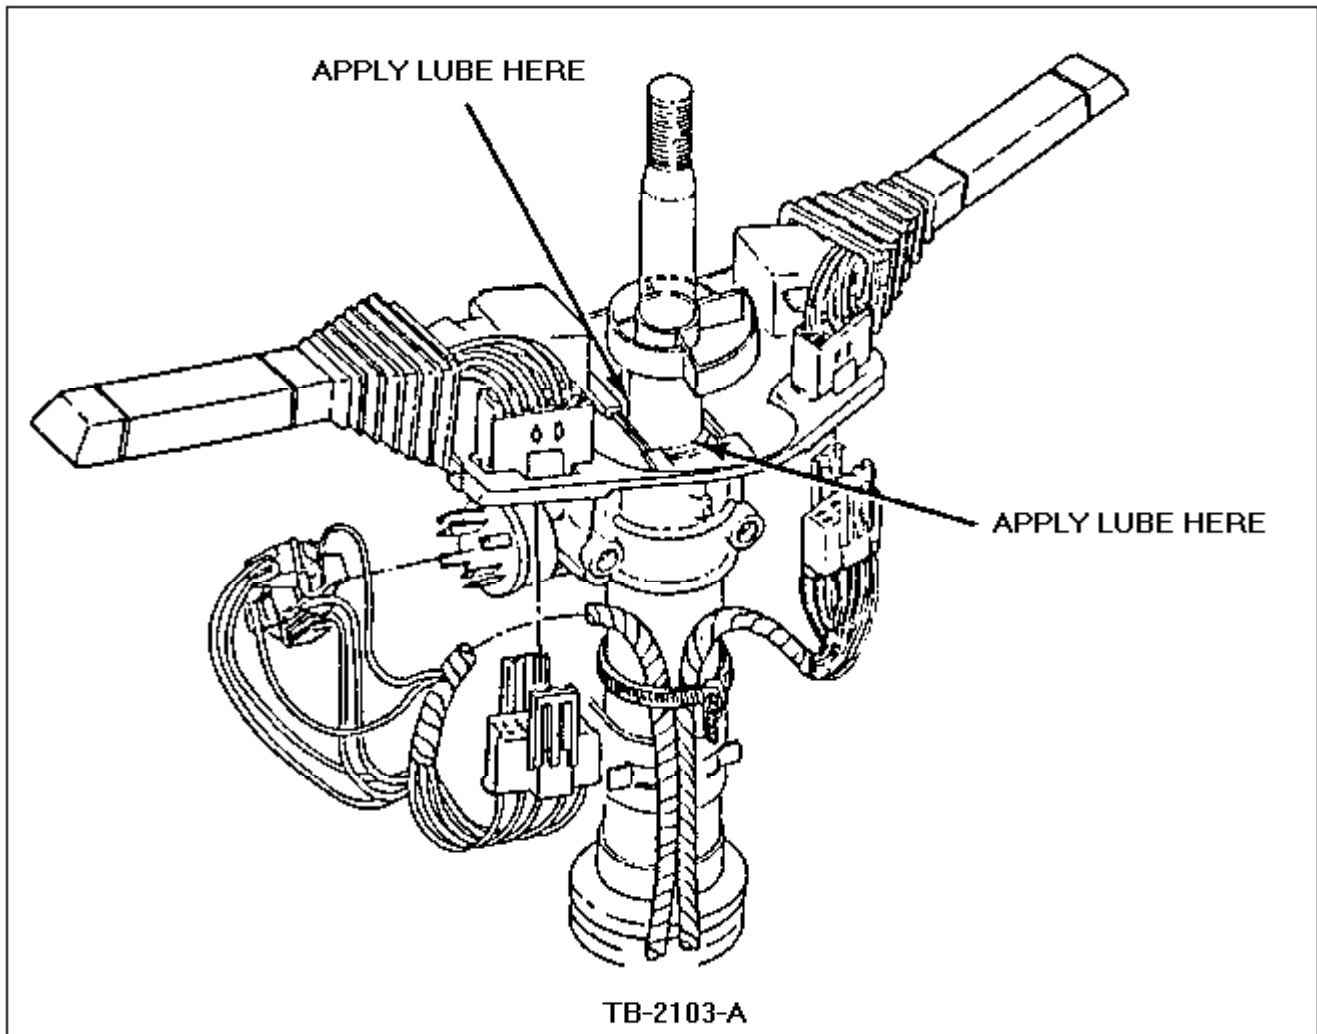
Figure 1 - Article 91-6-9

A "Squeaking" noise may be heard in the steering column when the steering wheel is turned. This condition may be caused by lack of lubricant where the turn signal cam is retained to the signal/wiper switch mounting plate.

1. Remove the steering column shroud from the left hand side of the column.
2. Apply Ford Multi-Purpose Grease on the bottom flange of the turn signal return cam. Refer to Figure 1.

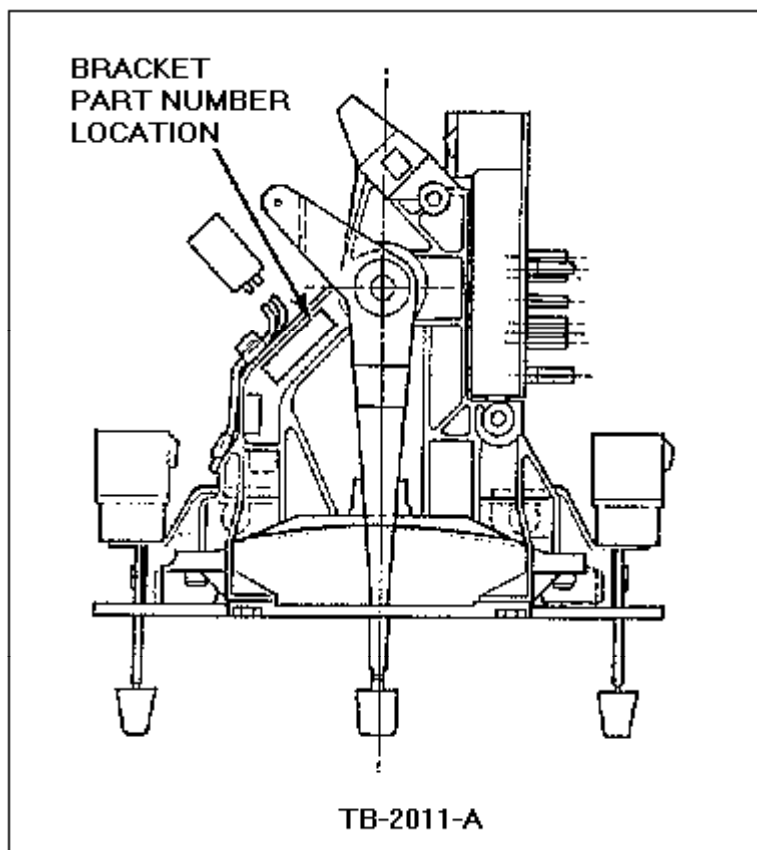
Figure 1 - Article 91-7-16

Lack of heat or air conditioning may be caused by the temperature control lever disengaging from the climate control module.

1. If the climate control assembly is obtained from dealer stock, make sure it is the latest design level.
 - a. Look for the bracket part number (E4TH-18352-AA), Figure 1. This specific part number indicates that it is of the latest design level.

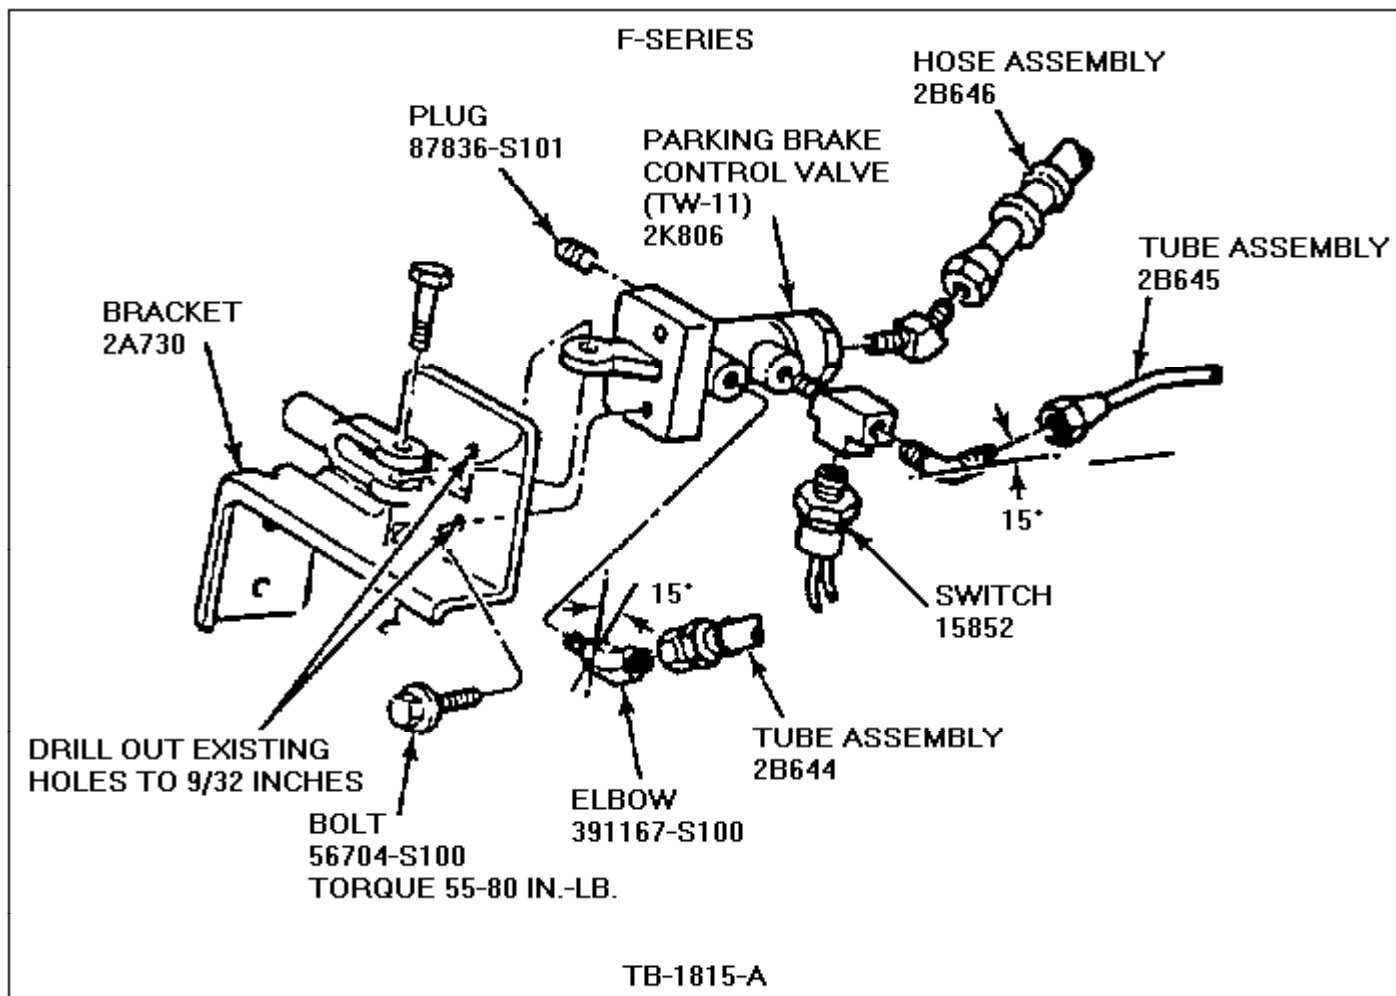
Figure 1 - Article 91-15-13

Revised TW-11 parking brake valves are available for service. The new valves have a new Viton "o"-ring at the input fitting to improve sealing. The valve used on F, L, and LN Series trucks also has a new material and casting pattern to reduce the number of ports. With fewer ports the number of possible leak points is reduced.

If service is required, install a new TW-11 parking brake valve. See the following chart for the correct part usage. Refer to the Medium/Heavy Truck Shop Manual, Page 12-75-8 for installation procedures for the F-Cowl and B Series Trucks. Use the pictorial installation procedure shown in Figures 1 and 2 for the F, L and LN Series Trucks.

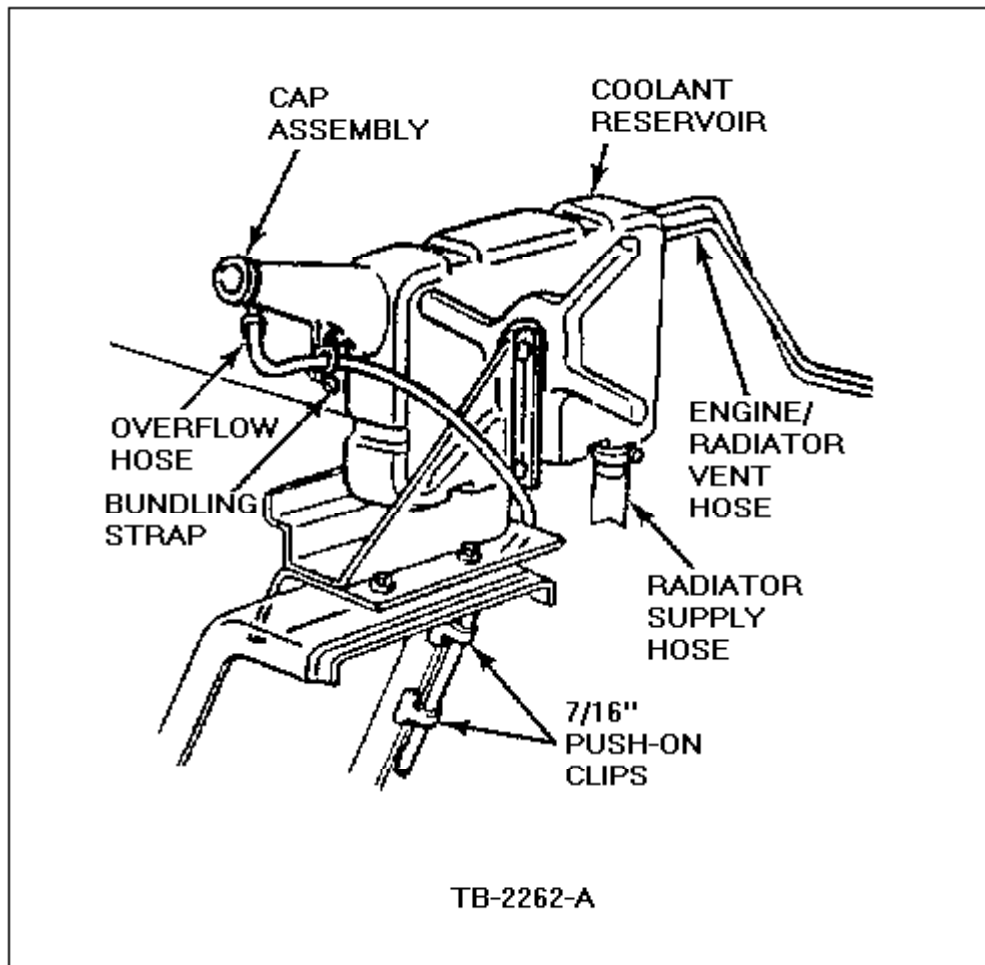
Figure 1 - Article 91-16-15

The cooling system reservoir may leak coolant because of cracks at the reservoir's mounting bosses.

Install a new more durable cooling system reservoir (F1HZ-8A080-D). Some additional components are required to complete a retrofit. Refer to the Parts Block and Figure 1 for correct parts usage. Refer to the 1986-91 Cargo Truck Shop Manual, Section 27-02, for complete cooling system service details.

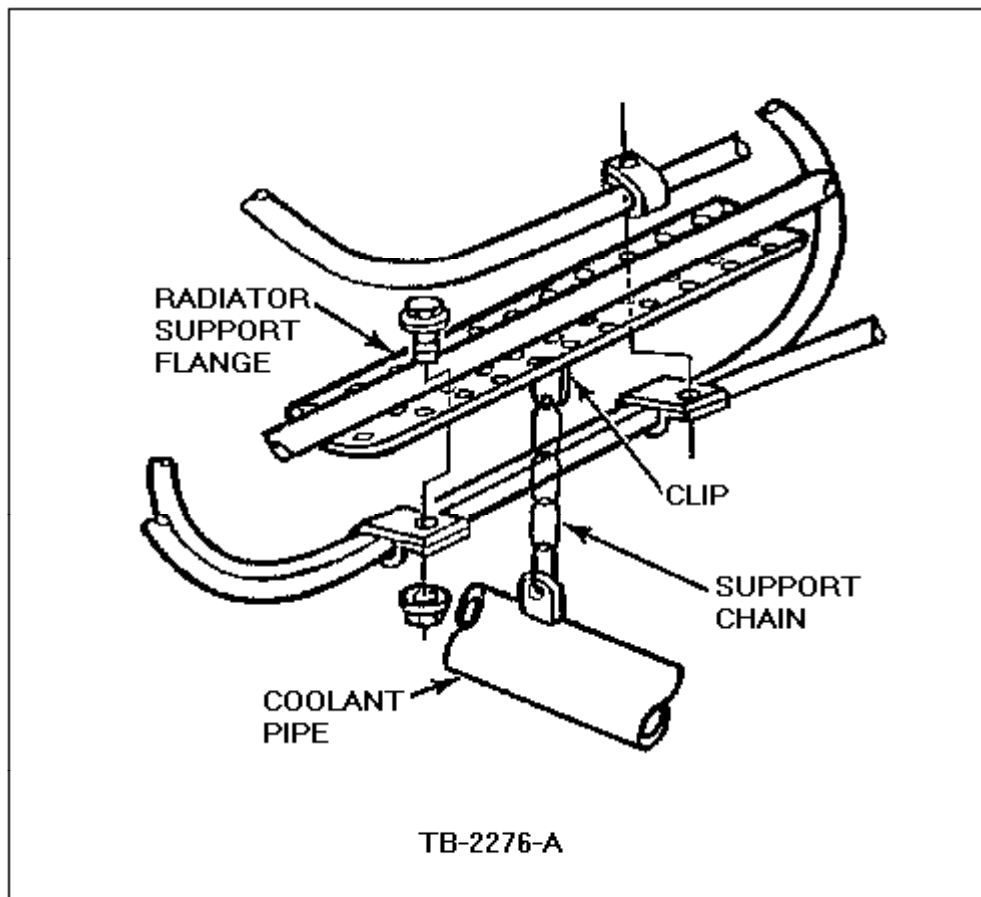
Figure 1 - Article 91-16-16

The upper engine-to-radiator coolant pipe may contact adjacent components and eventually cause a coolant leak. This occurs because of the positioning of the tube support chain which is connected to the radiator support rod.

1. Remove one link from the chain, Figure 1. Reattach as described in Step 2.

2. Reposition the support chain in the sixth hole from the front of the flange on the radiator support rod, Figure 1.

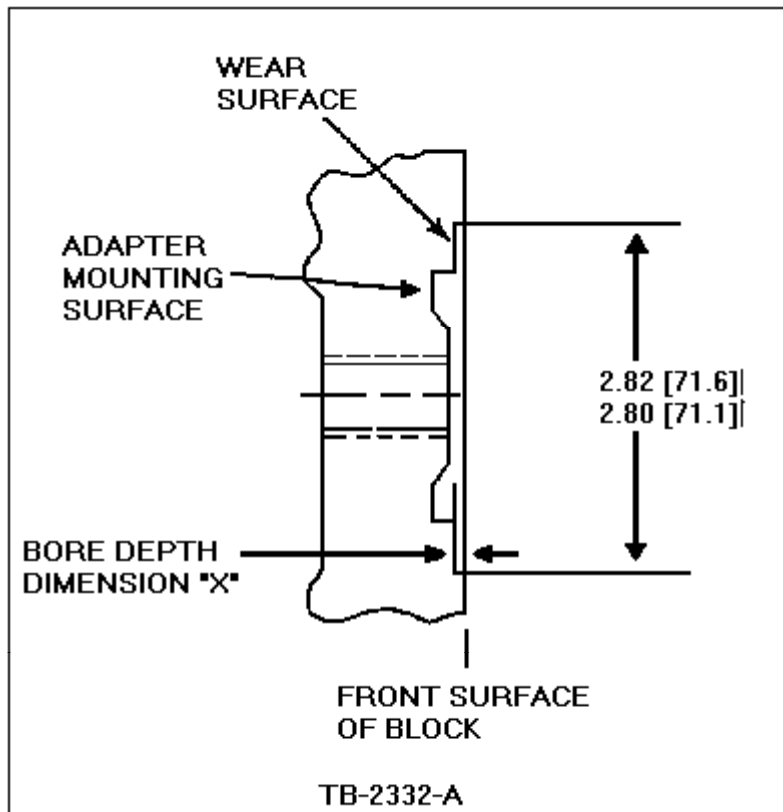
Figure 1 - Article 91-19-13

1. If camshaft drive gear end play is greater than 0.432 mm, (0.017 inches), rework is recommended.
2. Measure bore depth of dimension "X" at the 3,6,9 and 12 o'clock positions. Refer to Figure 1.

- a. If any two measurements differ more than 0.152 mm (0.006 inches), rework is recommended.
- b. If the "X" dimension is greater than 0.79 mm (.031 inches) at any point around the diameter, rework is recommended.

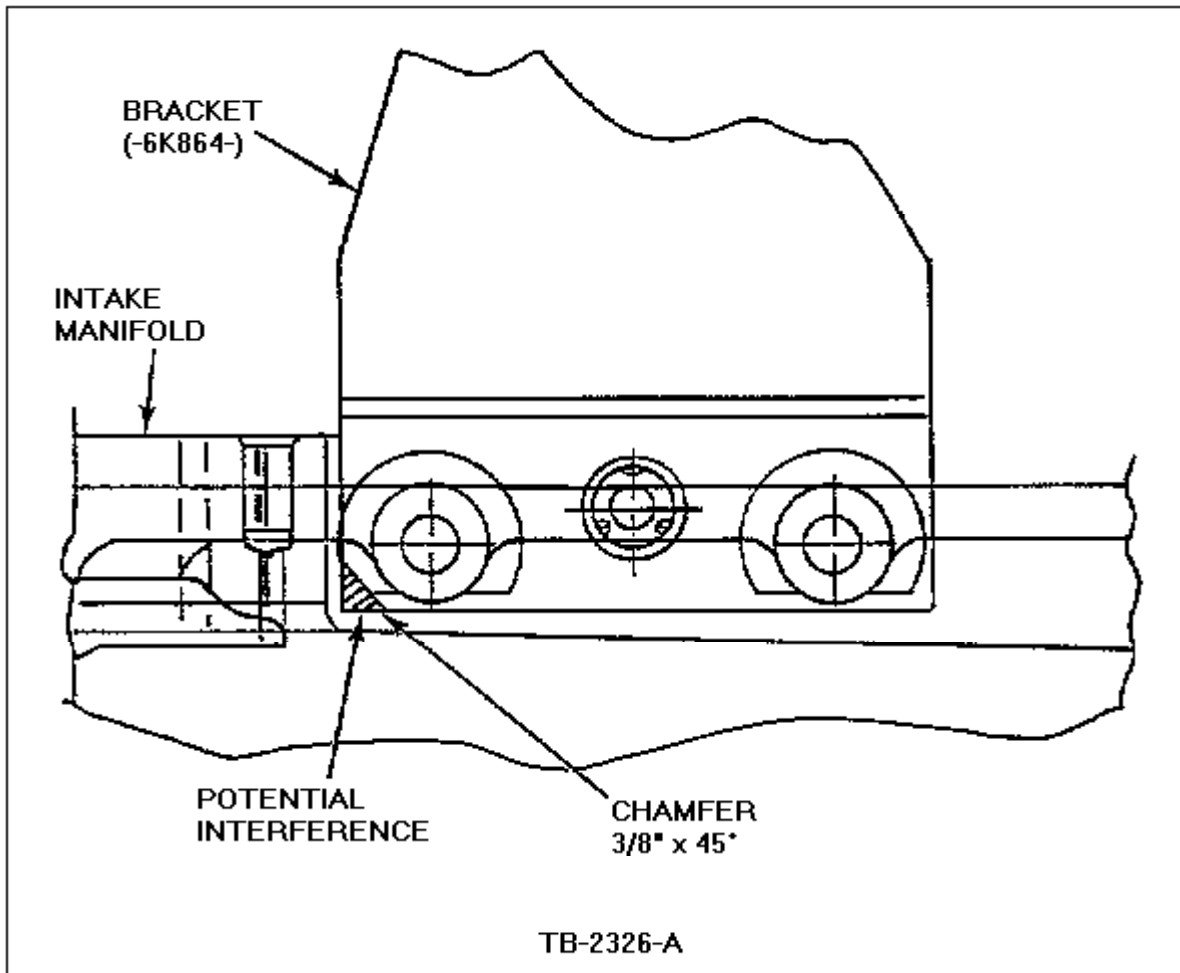
Figure 1 - Article 91-20-21

1. Check the adaptor bracket clearance to the engine intake manifold to see if there is a minimum clearance of 1/16" (1.588mm).
2. If this minimum clearance is not evident and the bracket is reusable, rework it as shown in Figure 1.

- a. Remove the bracket and grind the rear, lower corner providing a chamfer of 3/8" (9.525mm) x 45°.
- b. Reinstall the bracket using the existing fasteners. Tighten all fasteners to 16-24 lb-ft (27-33 N-m).
3. If the adaptor bracket is not reworkable, install a new bracket (F1HZ-6K864-C) which is already chamfered.
