90-1, *Publication Date: JANUARY 4, 1990*

Hard Start - All With Duraspark II Ignition Modules - Revised Applications

**Article No.
90-1-5**

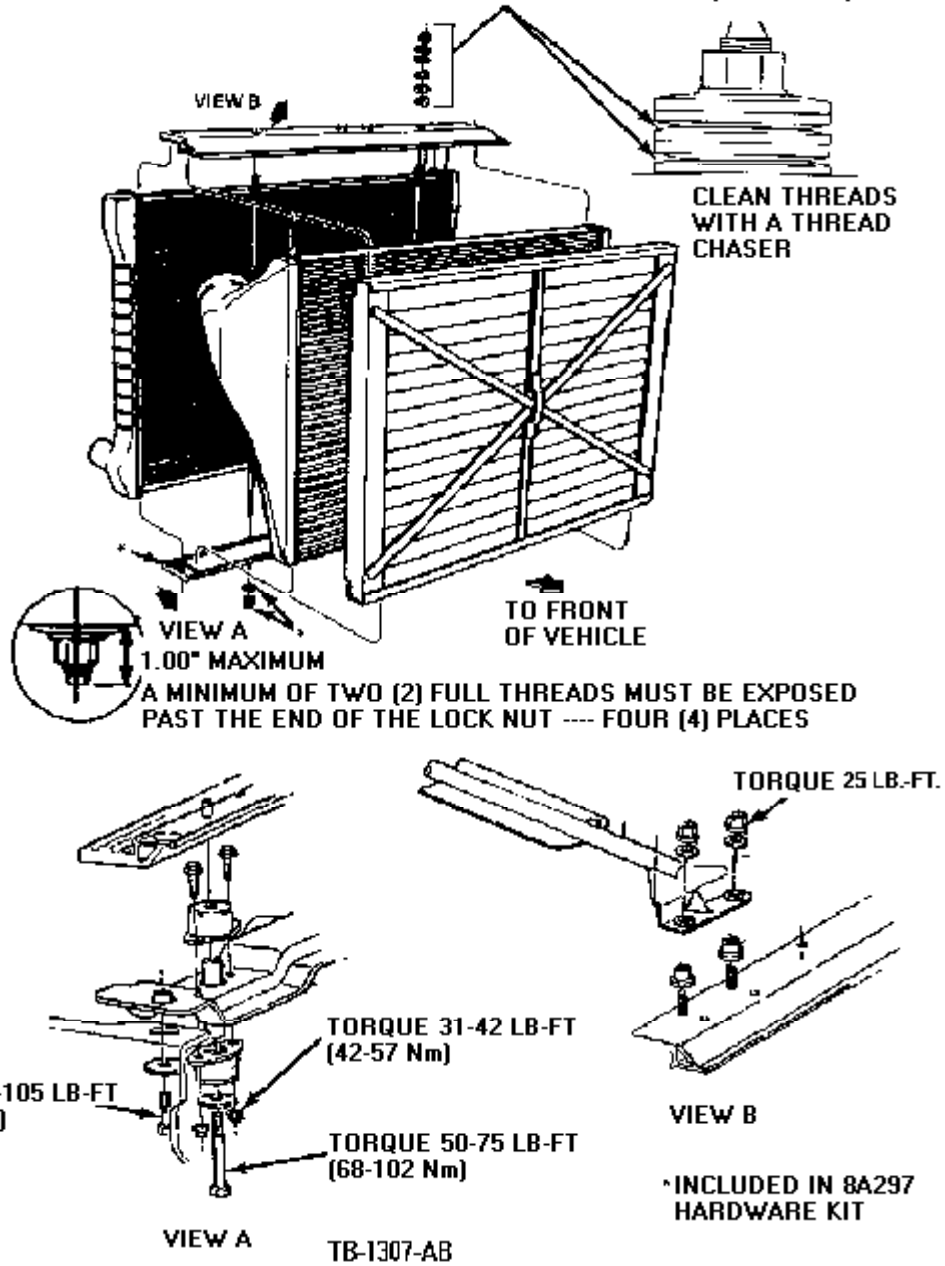
Figure 3 - Article 90-5-16

**L-SERIES (EXCEPT LL & LTL)
RADIATOR REMOVAL AND INSPECTION**

L-SERIES REQUIRES (5) BELVILLE SPRINGS
ARRANGED AS SHOWN. SPRINGS MUST
NOT BE FULLY COMPRESSED AFTER NUT IS
TORQUED TO 12-14 LB-FT (16-19 Nm)

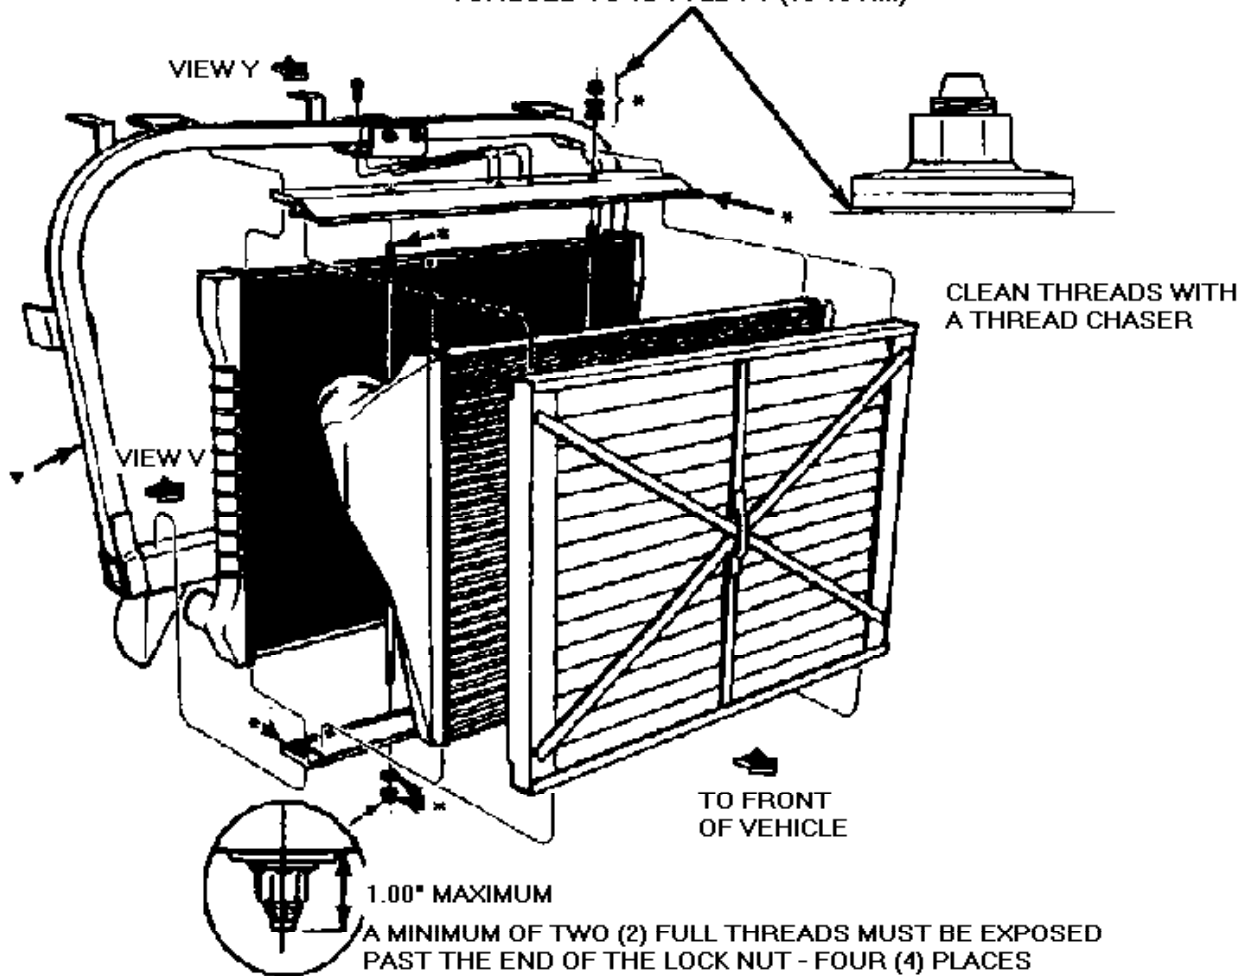
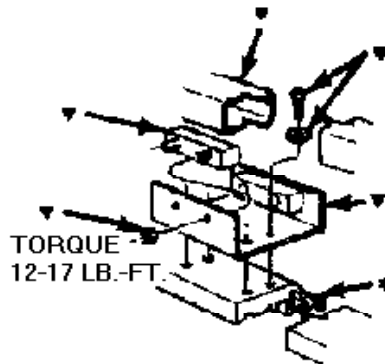
Figure 4 - Article 90-5-16

LL & LTL SERIES
RADIATOR REMOVAL AND INSTALLATION

LL & LTL SERIES REQUIRED (2) BELVILLE SPRINGS ARRANGED AS SHOWN. SPRINGS MUST NOT BE FULLY COMPRESSED AFTER NUT IS TORQUED TO 12-14 LB-FT (16-19 Nm)

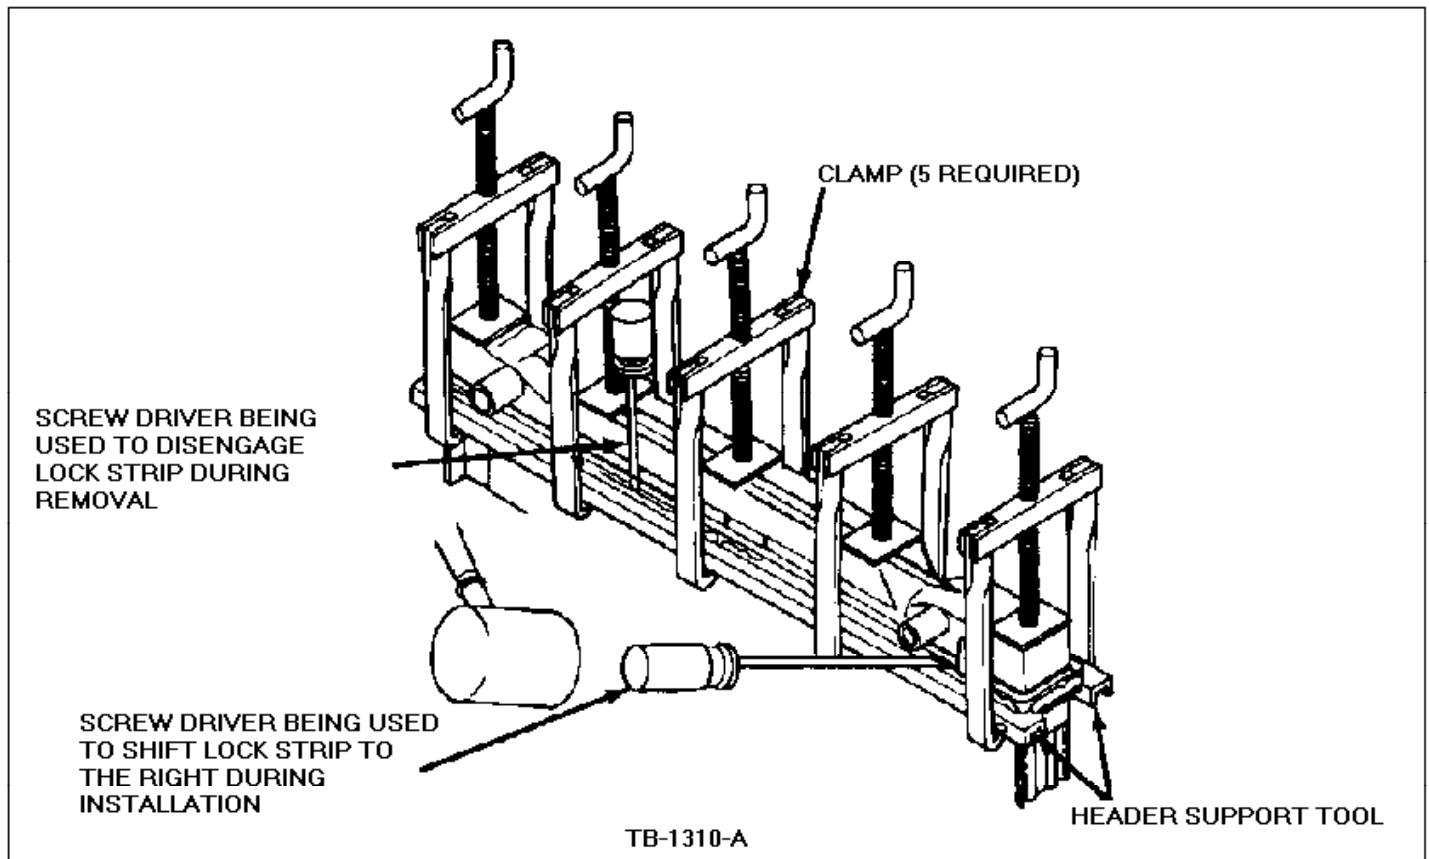
Figure 7 - Article 90-5-16

COMPLETELY SUPPORT THE HEADER TO PREVENT DISTORTION, FIGURE 7. IF THE HEADER BECOMES EXCESSIVELY DISTORTED, THE CORE MAY NEED TO BE REPLACED. THE HEADER MUST BE COMPLETELY SUPPORTED WITH A HEADER SUPPORT TOOL, FIGURE 8.

1. Position the header support tool and five header clamps as shown in Figure 7.
2. Hand tighten header clamps evenly until the locking strips become loose enough to be removed by hand or with the aid of a small screwdriver, Figure 7.
3. Remove the locking strip retainers if so equipped.
4. Remove all locking strips and throw away.
5. Loosen and remove header clamps and header support.
6. Lift tank from core header.
7. Remove the O-ring seal from the header and throw away.

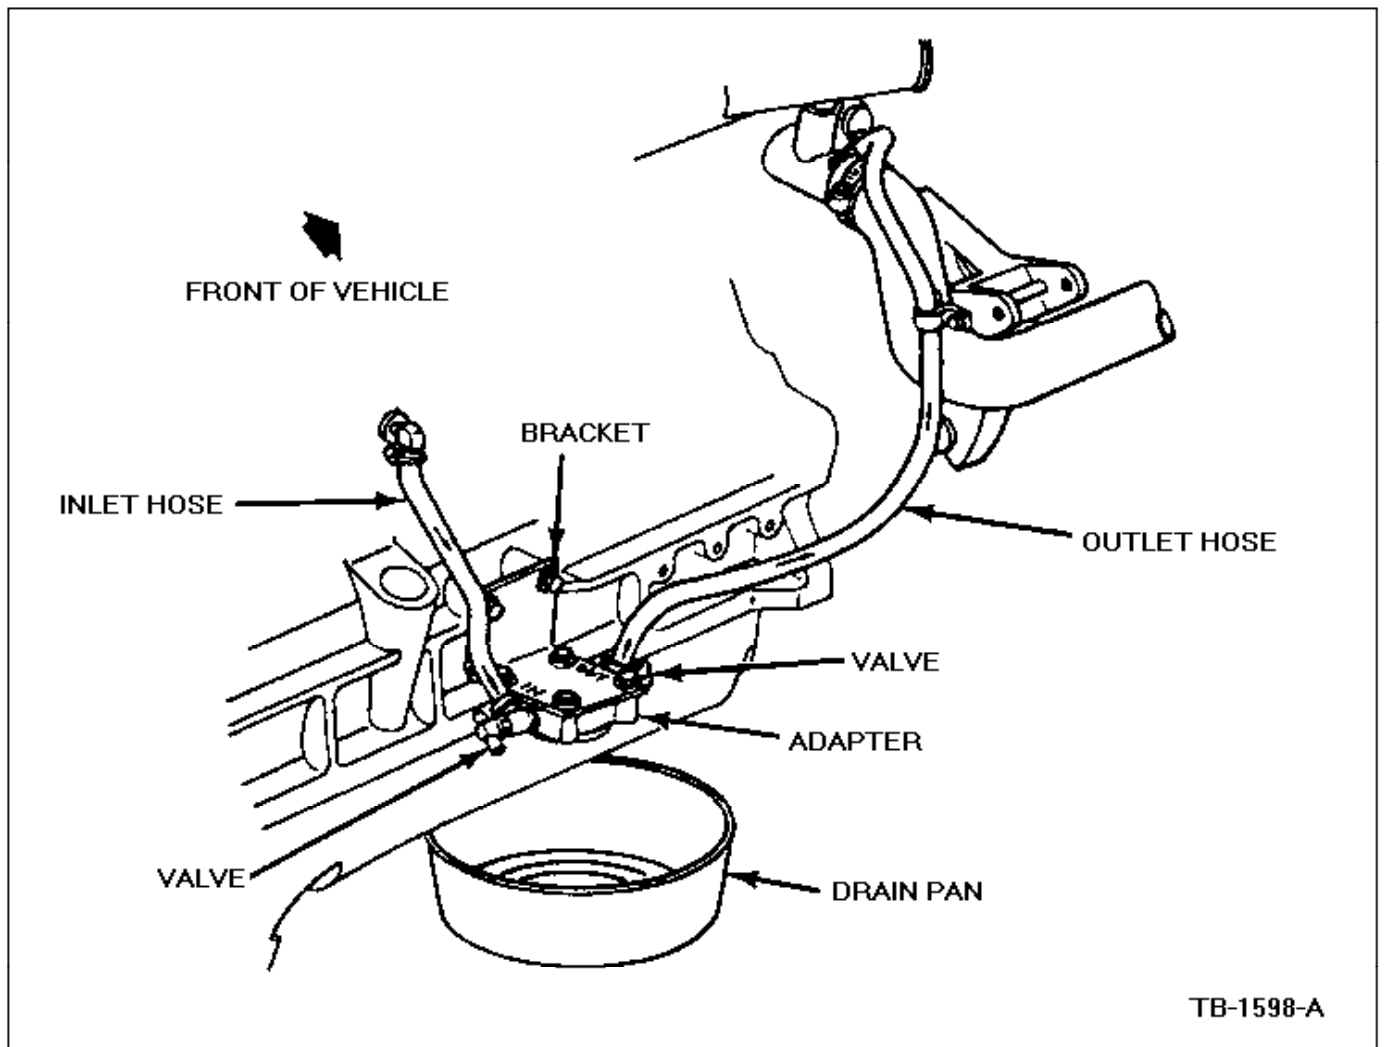
Figure 1 - Article 90-7-24

Incorrect coolant flow in the engine coolant filter may be caused by dirt in the filter's adapter and/or fittings.

1. Remove the coolant filter.
2. Place a drain pan beneath the adapter as shown in Figure 1.

3. Operate the inlet and outlet valves.
4. Watch the coolant flow from the inlet and outlet orifices of the adapter.
5. If coolant does not flow freely from the orifices, clean the filter adapter and fittings.
6. Replace the coolant into the cooling system after the new coolant filter has been installed.

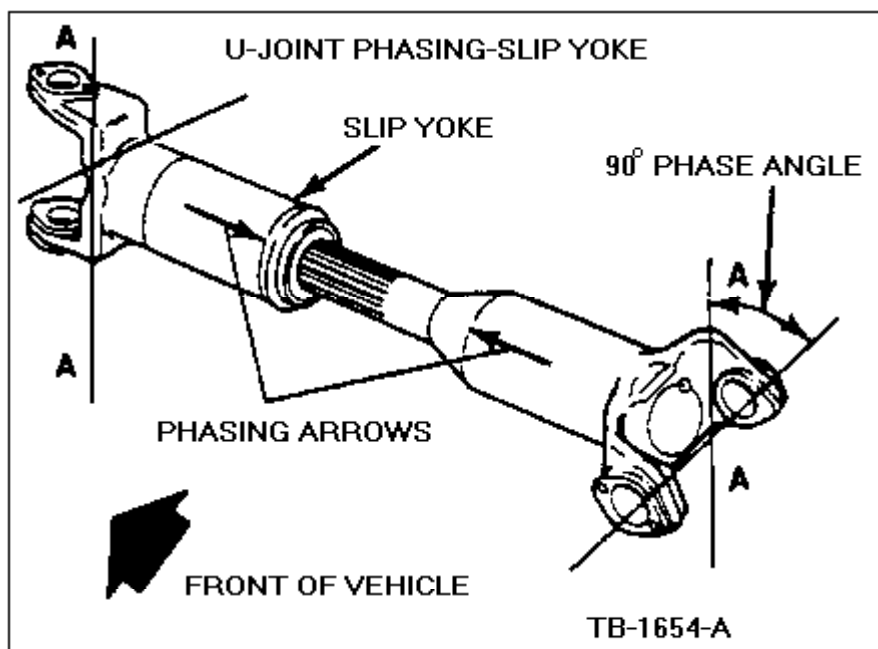
Figure 1 - Article 90-9-11

Some Ford heavy trucks are designed with "out-of-phase" 90° two (2) piece driveshafts, Figure 1. The primary reason for using the 90° phased driveshafts is to meet higher torsional acceleration demands of these vehicles.

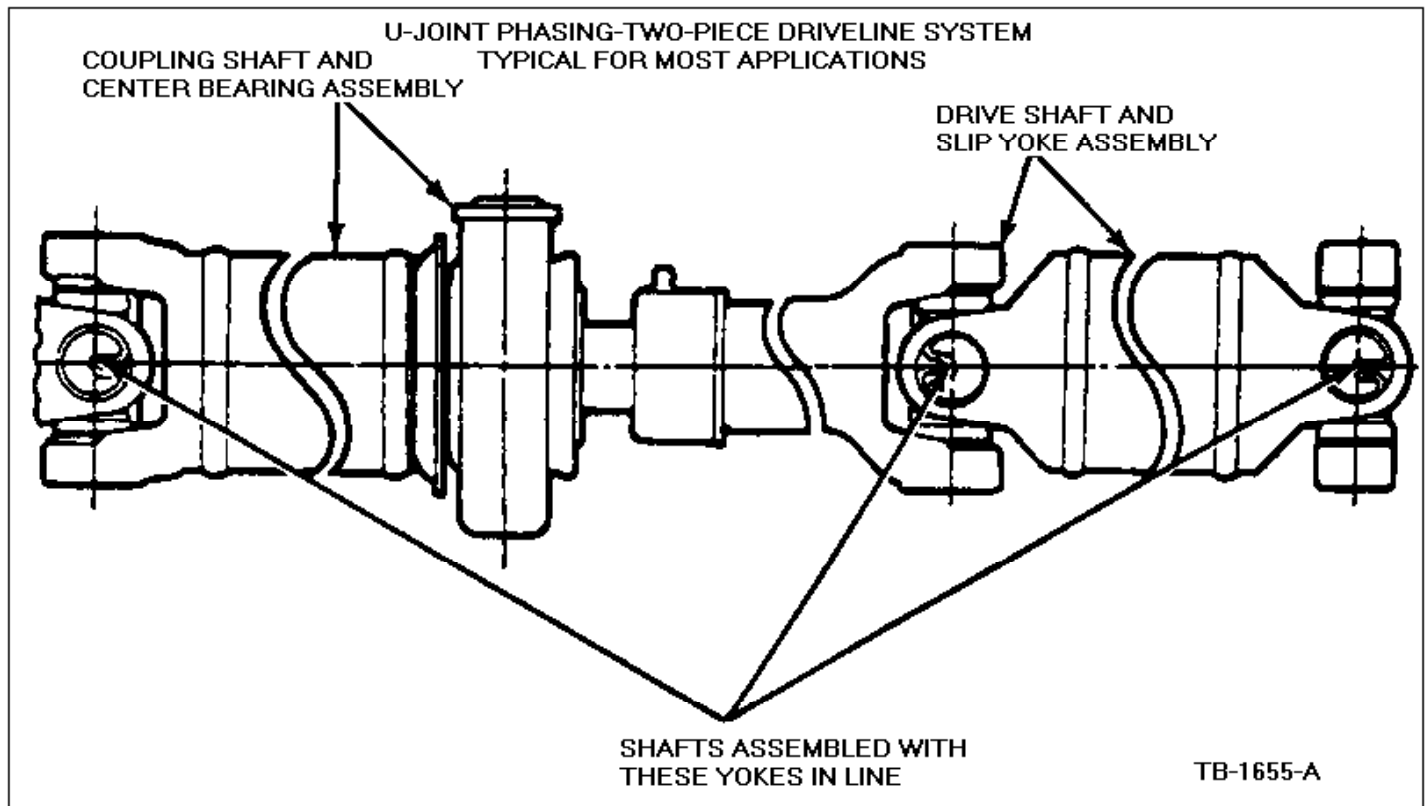
Figure 2 - Article 90-9-11

When U-joint yokes are assembled to their shafts in the same plane, they are "in phase"; when they are assembled to the shafts in different planes, they are "out-of-phase". Except as noted in TSB 88-24-10, most production drivelines use "in-phase" driveshafts with parallel yokes, Figure 2, for most applications to simplify driveline design, assembly and service.

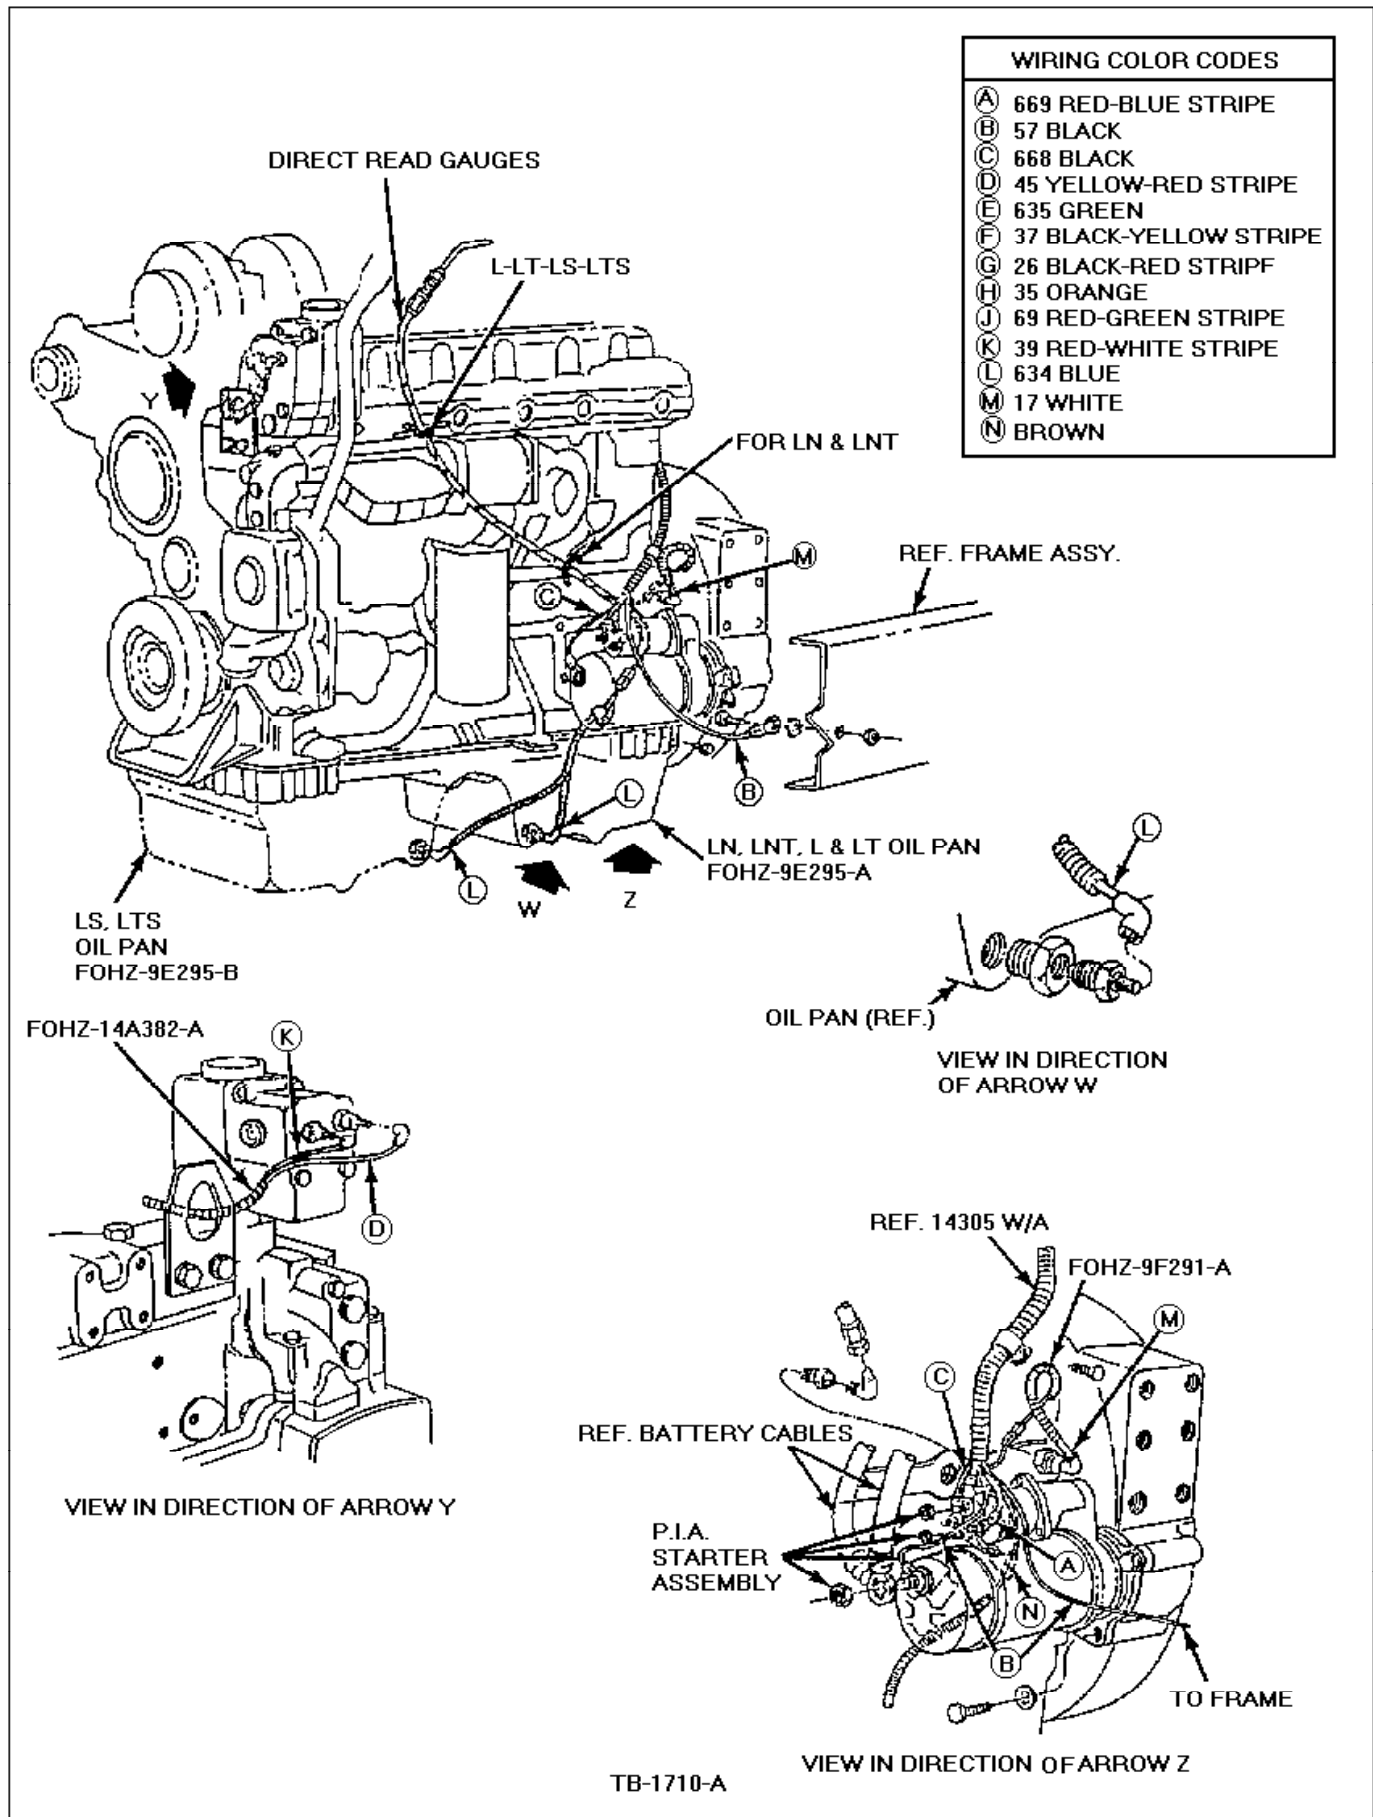
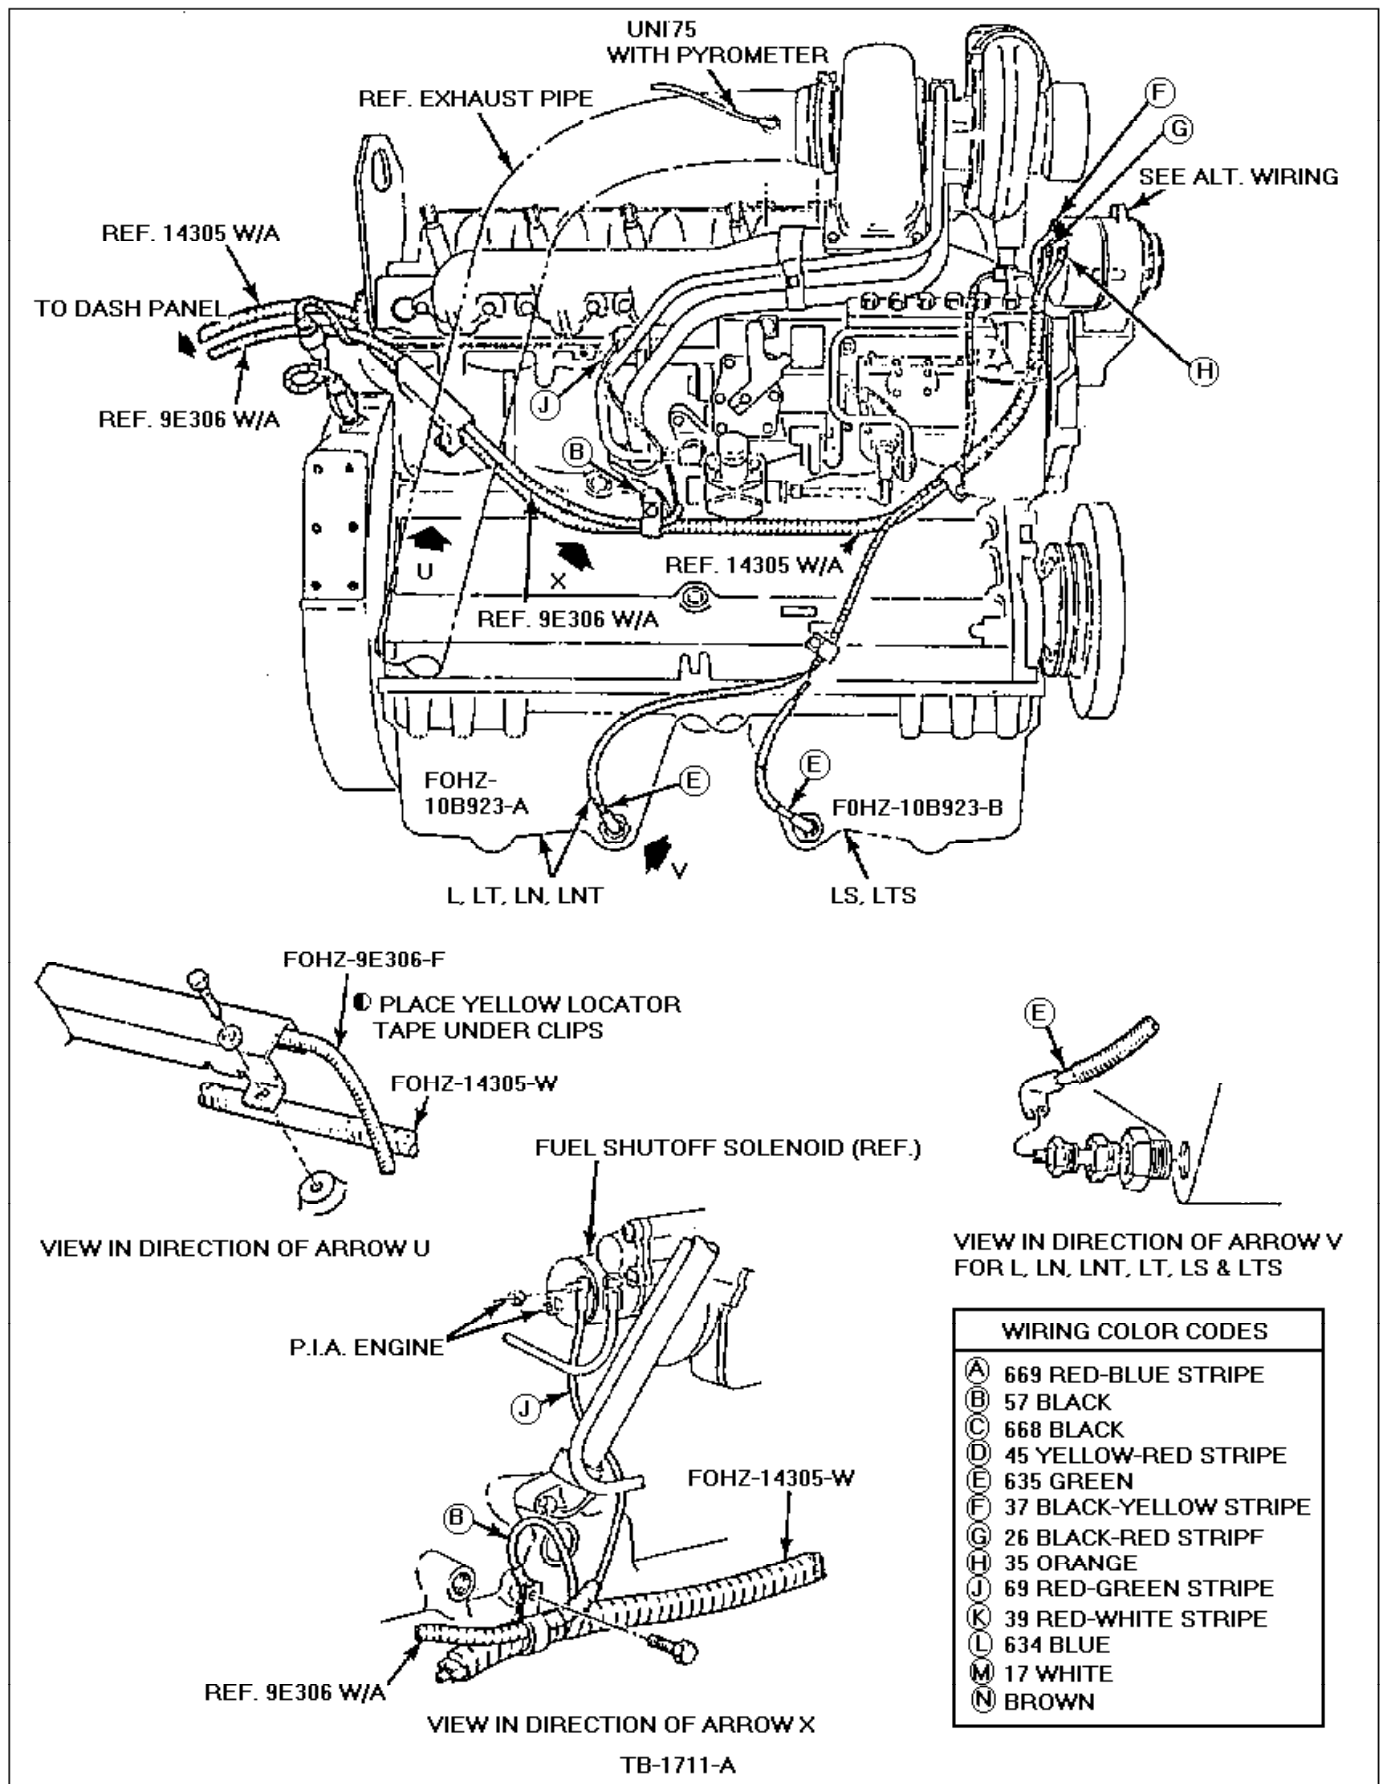
Figure 1 - Article 90-17-13

- Figures 1 & 2 detail the installation of the harnesses to the engine.

THE FAILURE MODE THAT CAUSED REPLACEMENT OF MOST OF THESE HARNESSSES WAS THE 9E306 FUEL SHUT OFF SOLENOID WIRE HARNESS RUBBING ON A BRACKET ATTACHMENT BOLT. THIS BOLT IS LOCATED ON THE LEFT HAND SIDE OF THE ENGINE NEAR THE FUEL PUMP.

If service is required, refer to the following Wiring Harness Application Chart for correct wiring harness usage. Refer to Figures 1-5 for installation and routing details.

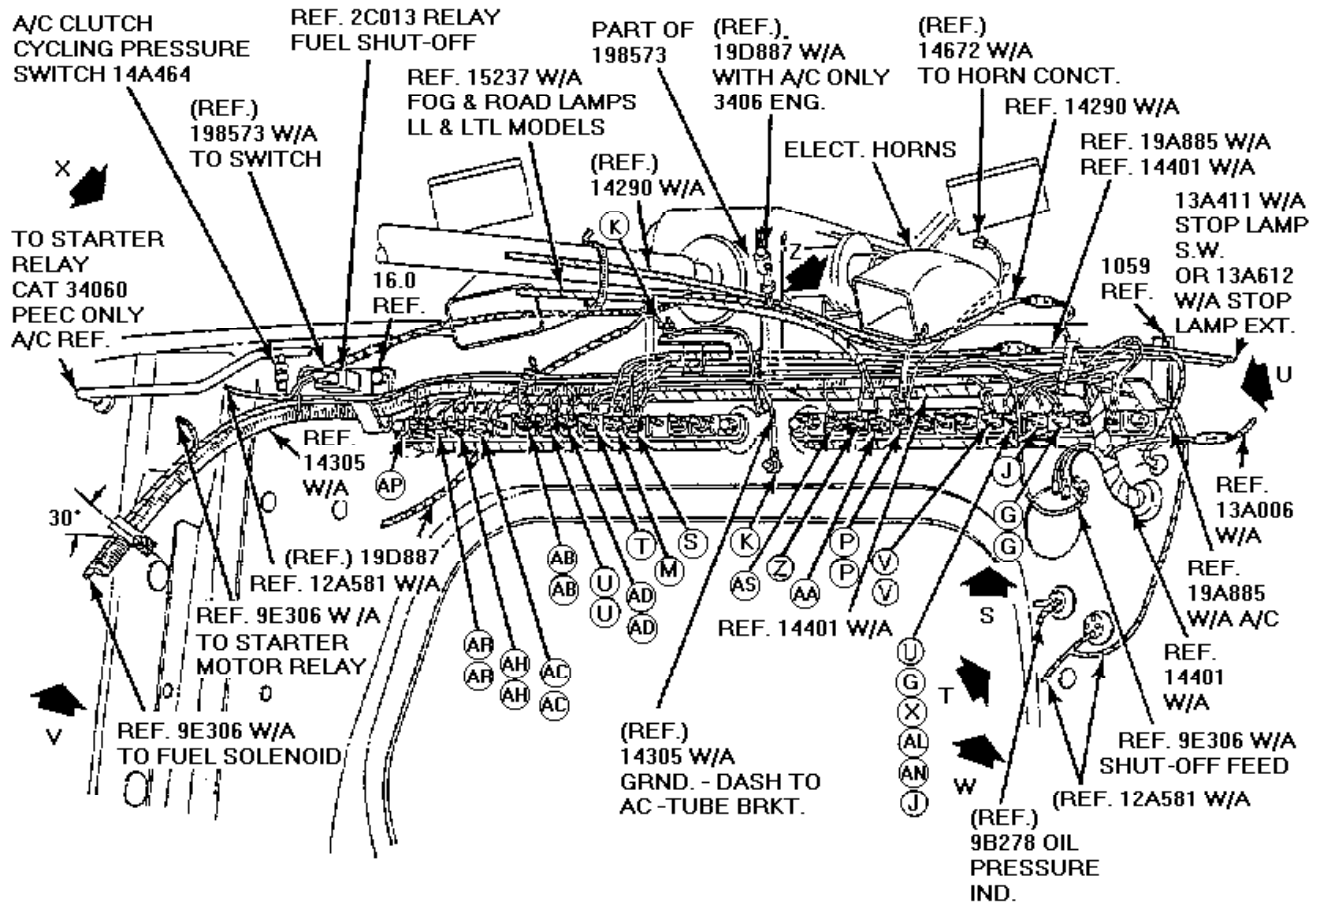
Figure 3 - Article 90-17-13

- Figure 3 shows the harness installation to the terminal strips at the dash.

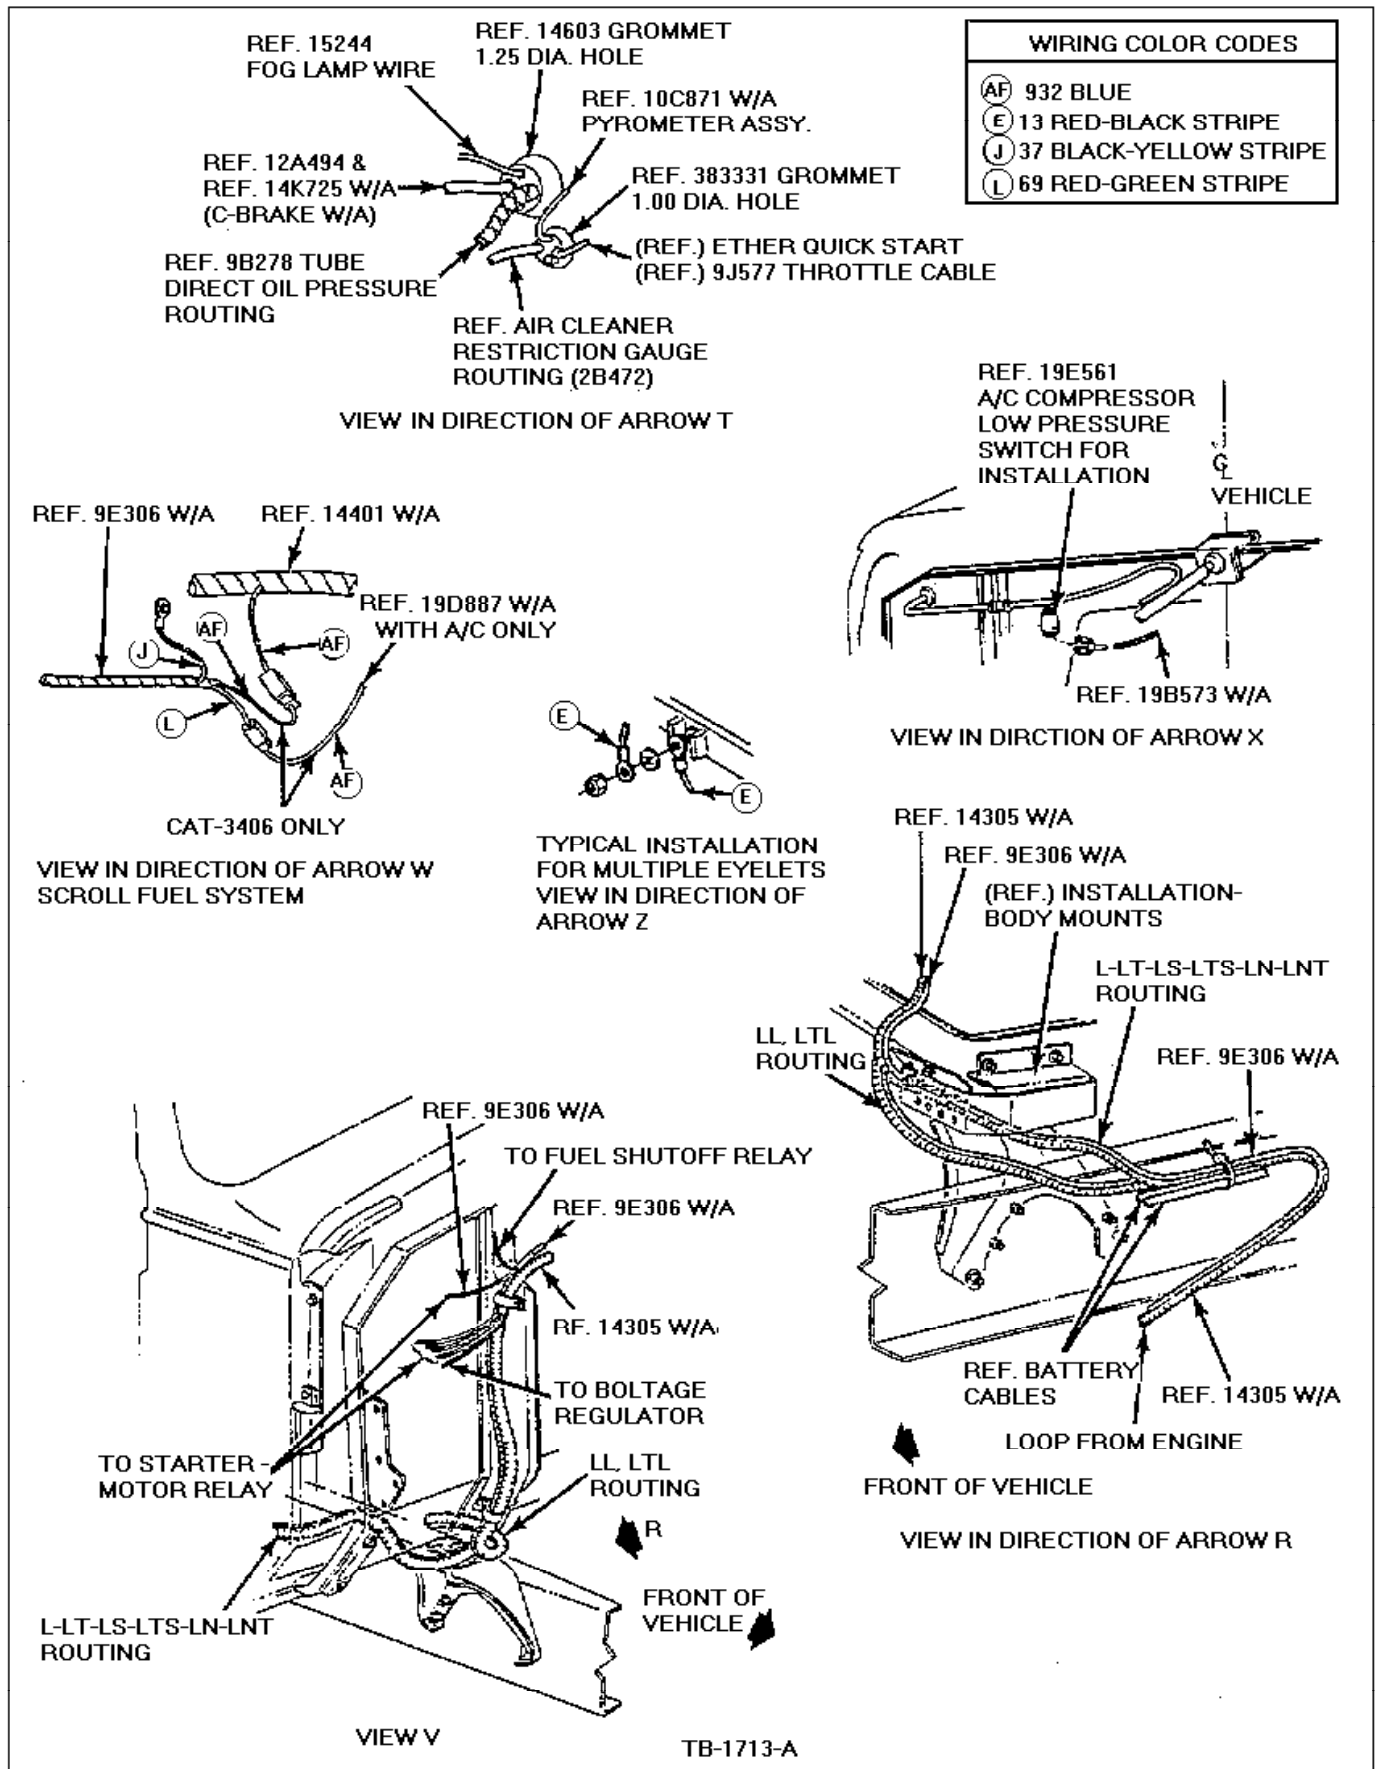
Figure 4 - Article 90-17-13

- Figure 4 shows proper wiring harness routing around the frame.

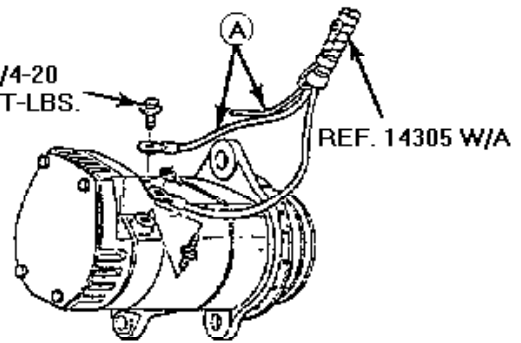
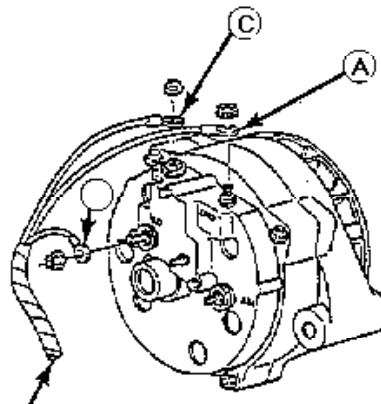
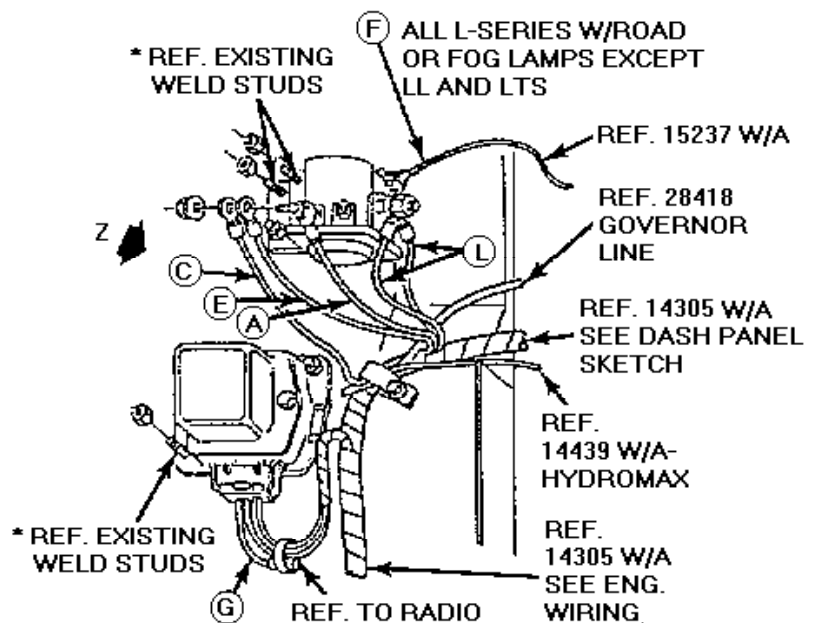
Figure 5 - Article 90-17-13

- Figure 5 details the attachment of the wiring harnesses to the starter, alternator and solenoid/voltage regulator.

* NOTE: MOUNTING STUDS MUST BE
FREE OF PAINT AND PAINT
MASKING MATERIAL BEFORE
INSTALLATION OF REGULATOR
OR STARTER RELAY

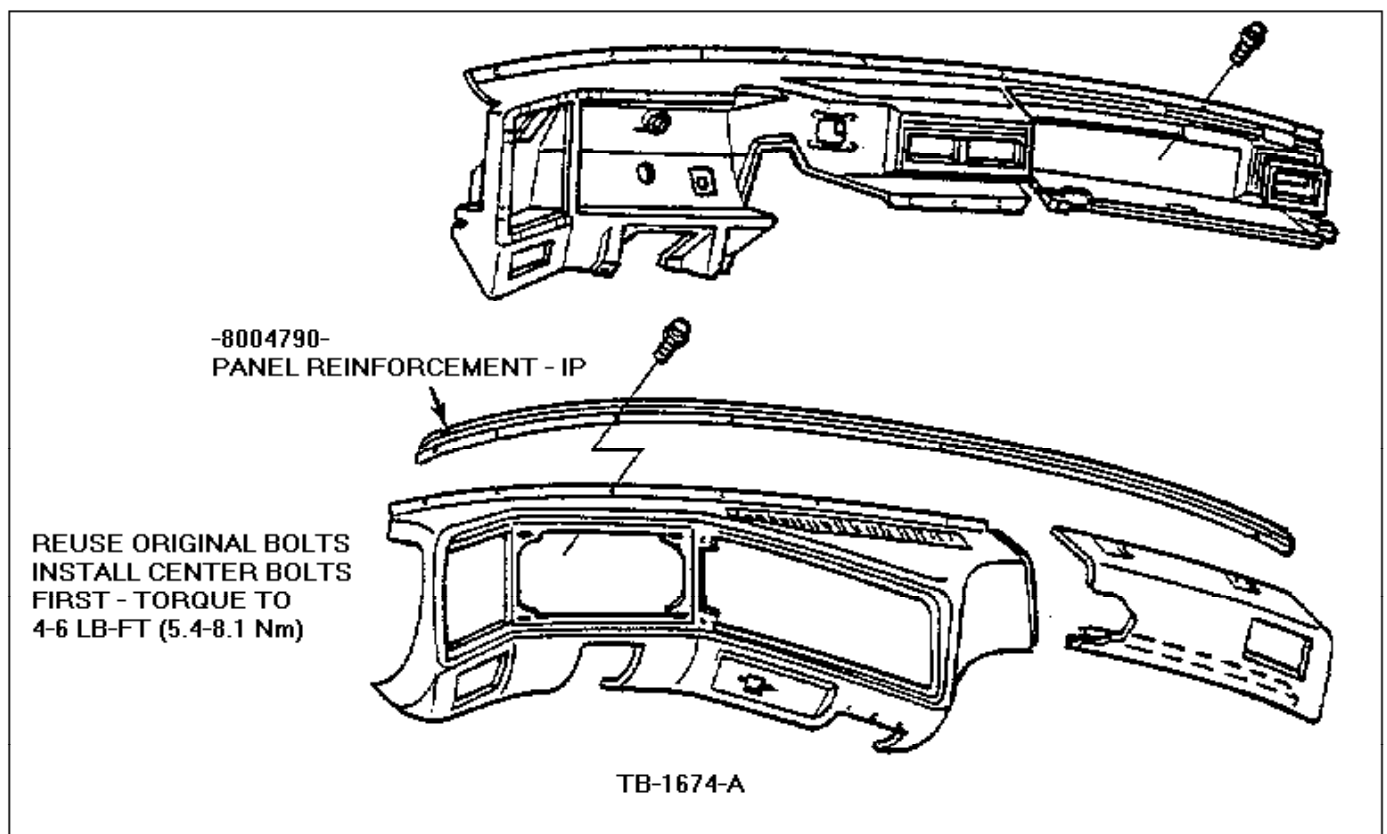
Figure 1 - Article 90-26-13

Instrument Panel - Cracked - Repair Procedure

1. Remove the eight instrument panel installation bolts below the windshield.
2. Lay the reinforcement strip on top of the instrument panel as shown in Figure 1.
