91-2, *Publication Date: JANUARY 23, 1991*

MEDIUM/HEAVY TRUCK:

1987-91 CARGO SERIES, F & B SERIES, L SERIES

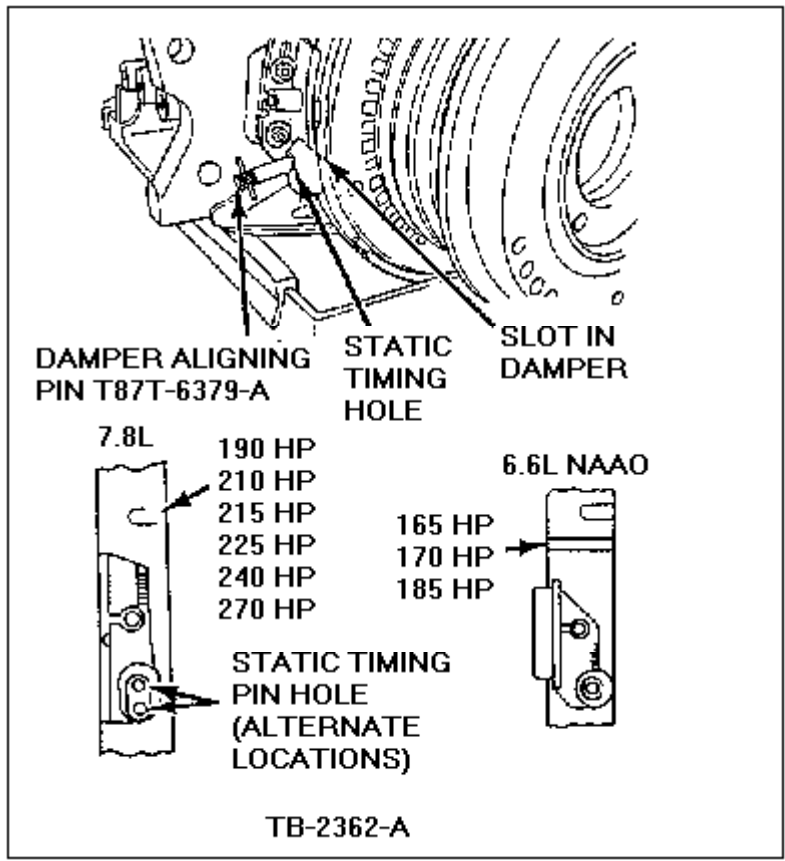
Figure 1 - Article 91-21-14

The engine may misfire or stumble and there may be excessive blue/white exhaust smoke during all ambient temperatures. This is caused by the static timing not being properly advanced.

1. Remove the injection pump access cover and basket.
2. Rotate the engine clockwise.
 - a. Set engine at correct static timing angle with number 1 piston on the compression stroke.
 - b. Fit Damper Aligning Pin (T87T-6379-A) through the timing bracket into the correct crankshaft damper groove, Figure 1.
