This Technical Bulletin provides instructions for updating mBSP ECUs in response to SPN 629 FMI 11 and SPN 523000 FMI 2 error codes on vehicles equipped with part numbers:

Flashing Process

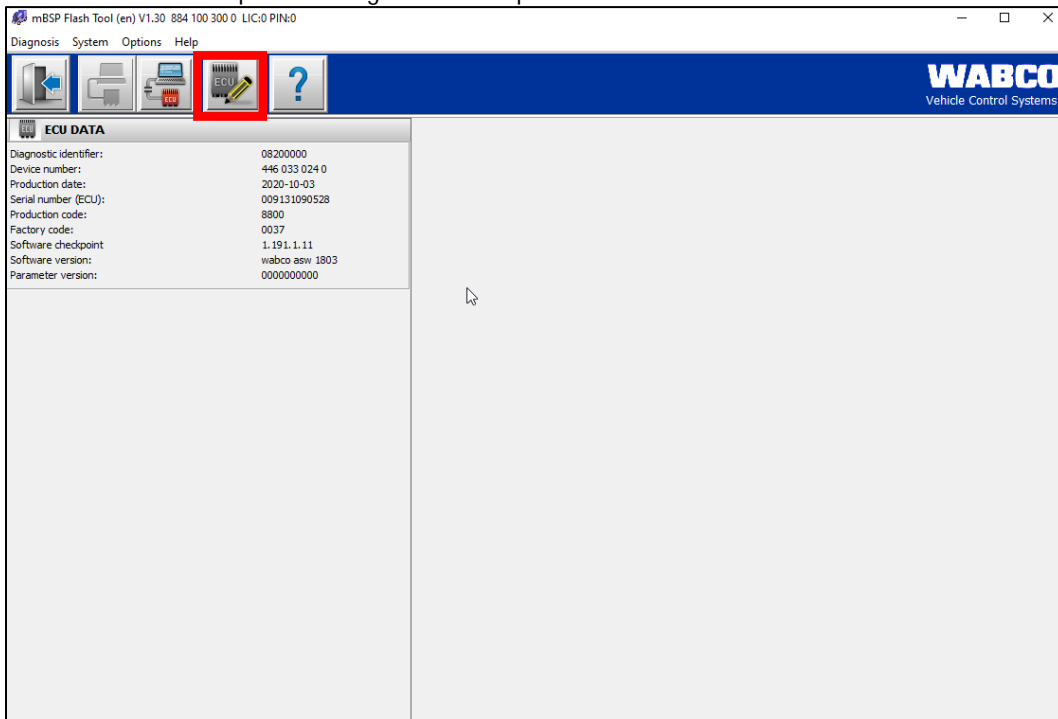
10. Click "ECU software update" to begin the ECU update.

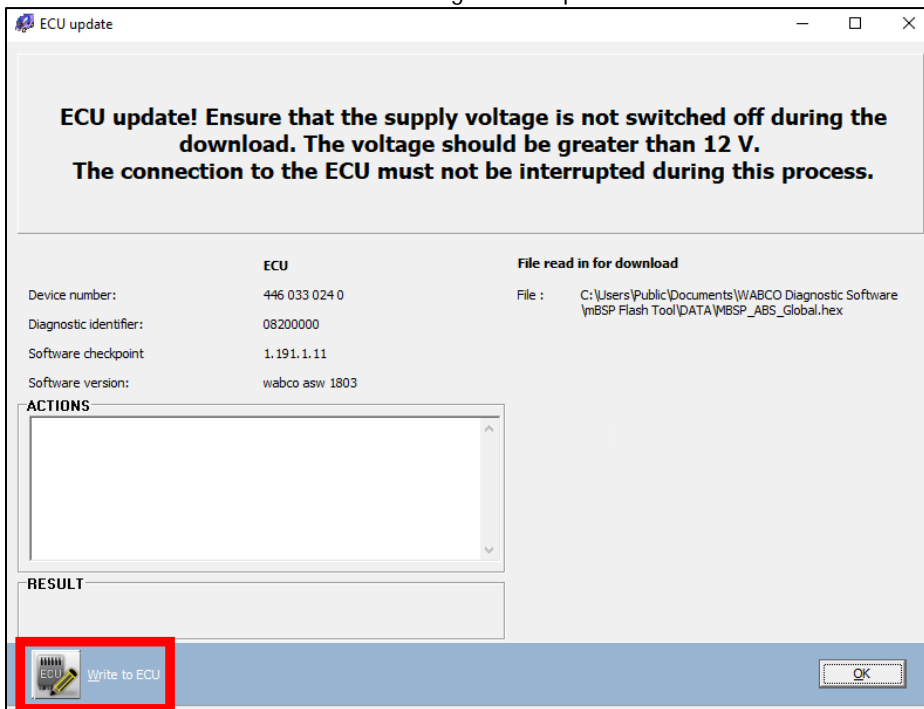
11. Select "Write to ECU" and the ECU will begin to be updated.

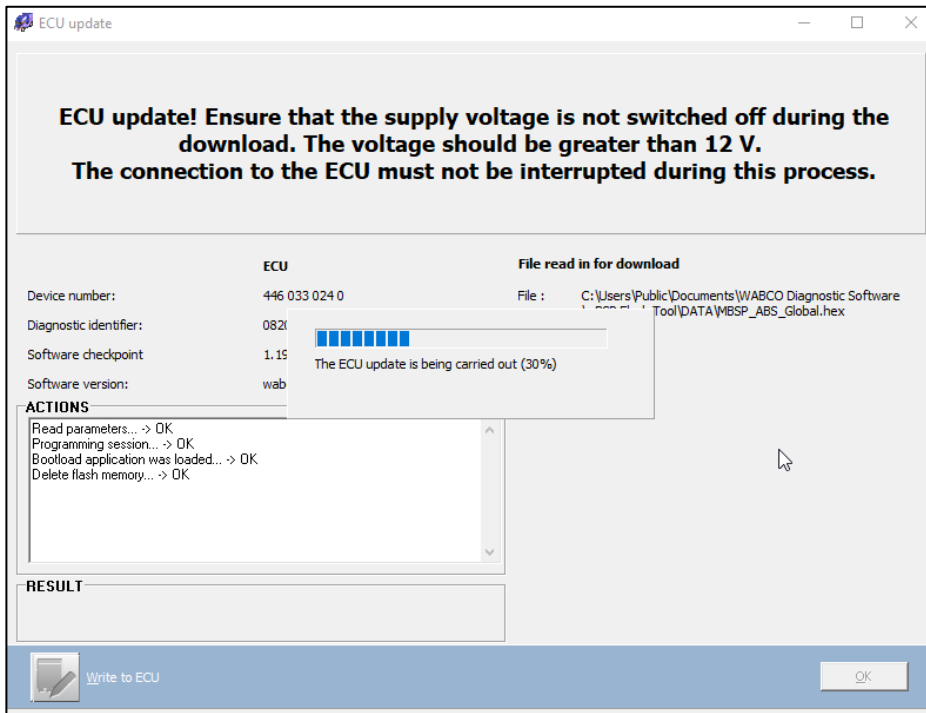
Note This process may take several minutes. Do NOT disconnect, turn key off, or allow PC to go to sleep

during this process.

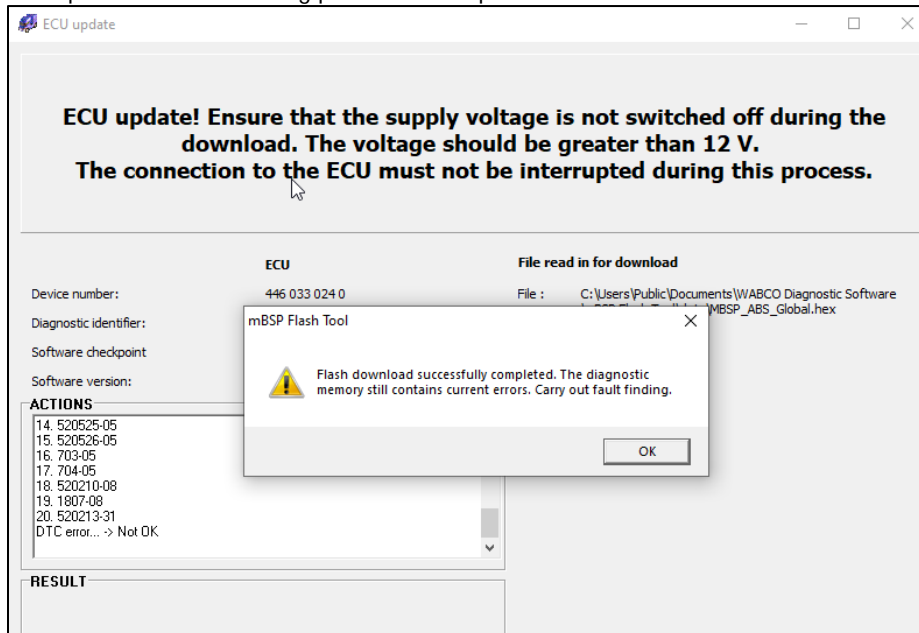
12. Once the ECU update has been completed some ECU errors may be present. *Note* ESC Calibration will be required after the flashing process is completed.

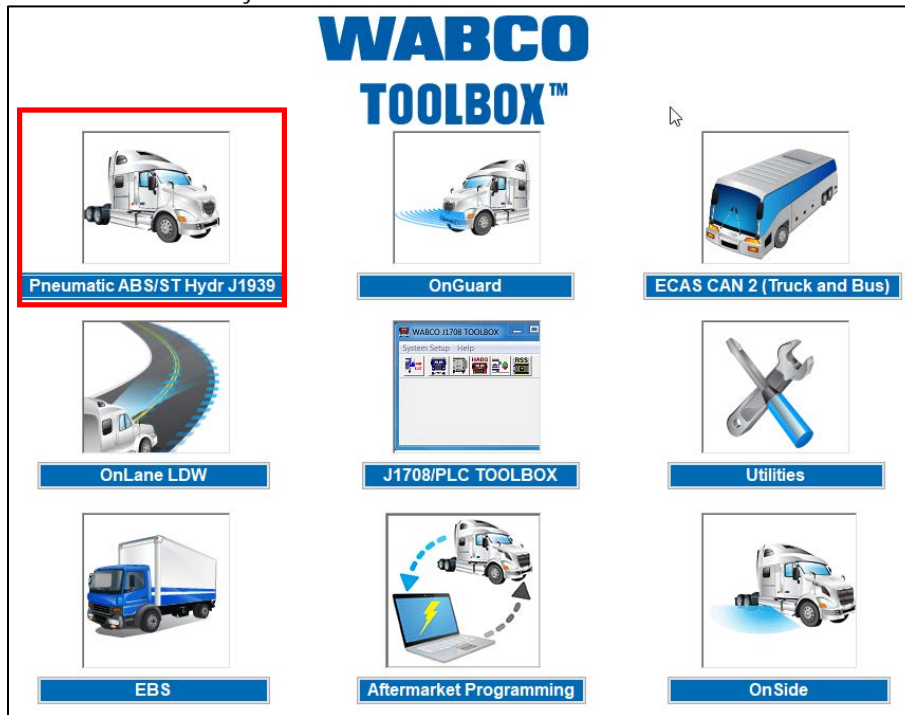
13. Save a Parameter file from the ECU as proof the parameter update was completed successfully and add to the Vehicle Repair Order. This can be done in WABCO Toolbox. Launch the Toolbox software and select "Pneumatic ABS/ST Hydr J1939".
